关于 Gen10 或 Gen10+服务器开启 S100i 软 raid 且配有 MR 阵列卡的情况下，

在 windows server 操作系统中运行 MRSA (8.8.12.0 及以上) 或 StorCLI

(7.2812.0 及以上) 高版本工具时，会出现蓝屏死机和意外重启的现象

Advisory: HPE MegaRAID Storage Administrator (MRSA) Software or Storage Command Line Interface (StorCLI) Tools on Servers Running Microsoft Windows - Blue Screen of Death (BSOD) and Unexpected Reboot if S100i Gen10 or SR100i Gen10 Plus is Enabled.

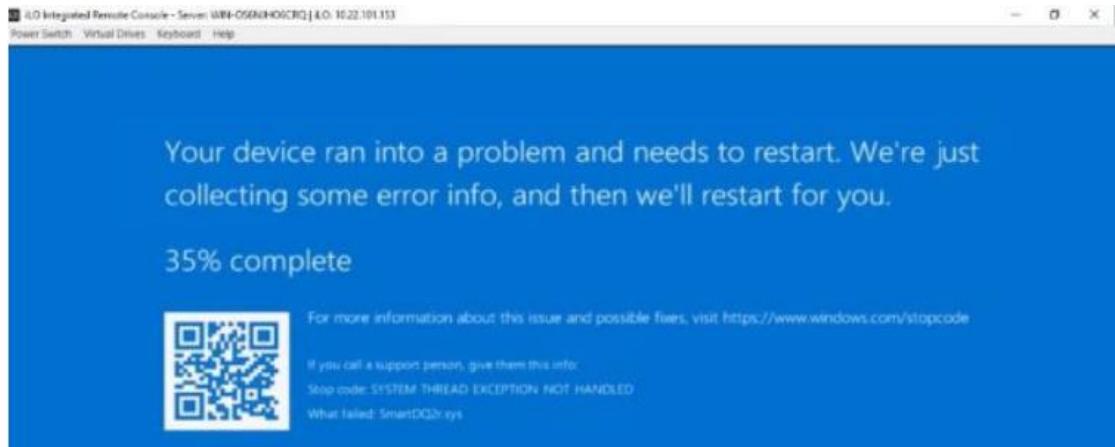
Example of Online MRSA Software Error:

Online MegaRAID Storage Administrator (MRSA) Software version 8.8.12.0 (or later) or the Software and Storage Command Line Interface (StorCLI) tools update version 7.2812.0 (or later) on the HPE ProLiant Gen10 or Gen10 Plus servers produces the Blue Screen of Death (BSOD) and unexpectedly reboots if the server enables the HPE S100i Gen10 or the HPE SR100i Gen10 Plus Software RAID.

Please note that the MRSA software and StorCLI tools cannot be reverted to an earlier version, and an **OS re-install is the only solution at this time.**

As a workaround, do not update MRSA to version 8.8.12.0 (or later) or the StorCLI tools to version 7.2812.0 (or later) if the server enables the HPE S100i Gen10 or the HPE SR100i Gen10 Plus Software RAID.

If this issue has already occurred, reinstall the OS.

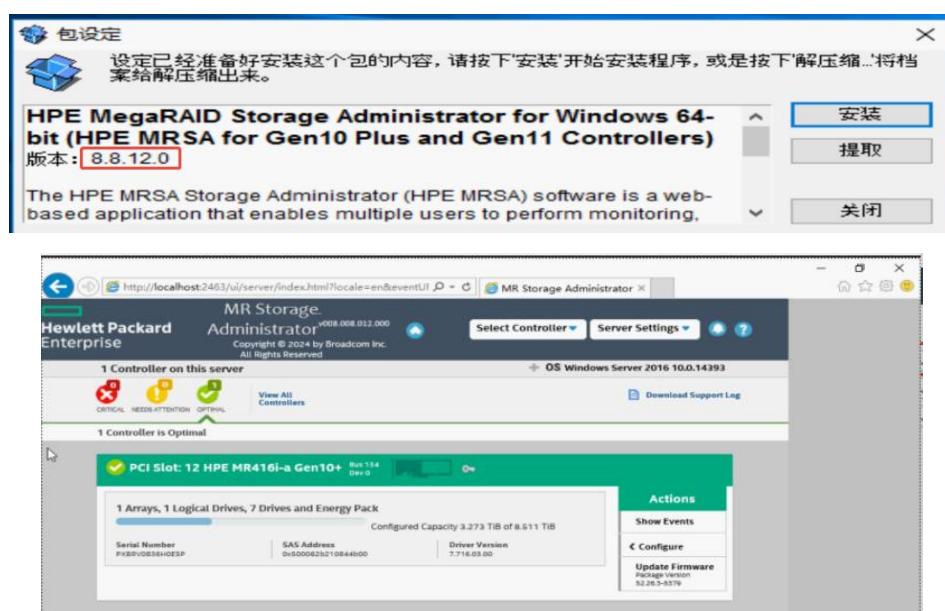
(1) 优先安装 8.8.12 版本（涉及公告问题的版本）的 MRSA，可以正常访问

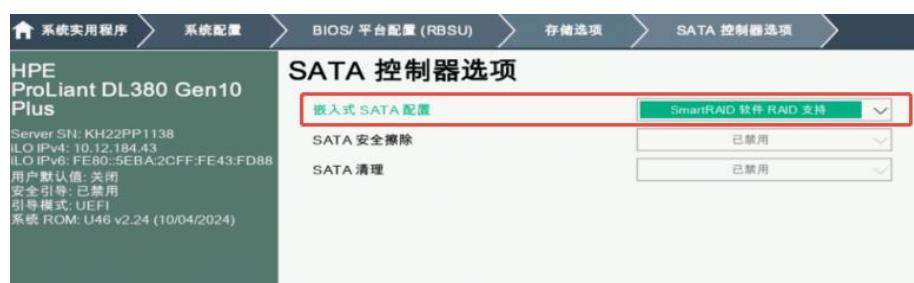
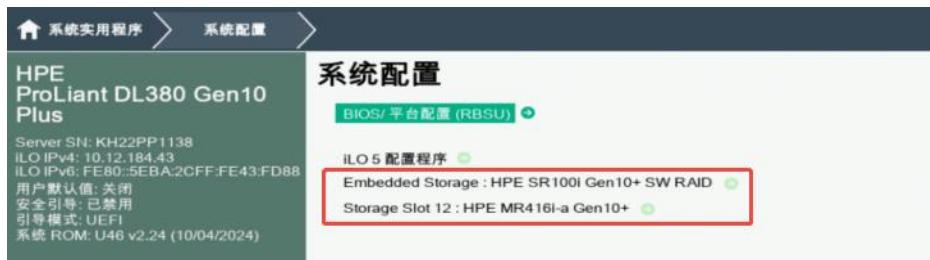
(2) 将 S100i 切换至 smart raid 模式后，仍可以访问 8.8.12 版本的 MRSA

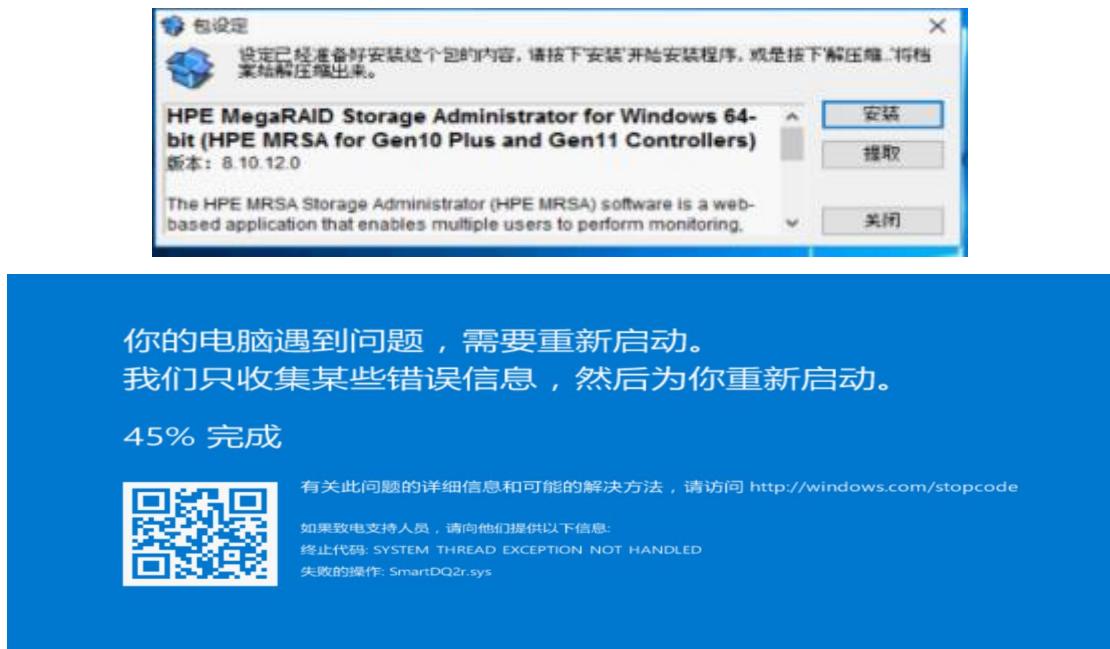
(3) 将 MRSA 升级至最新，触发蓝屏

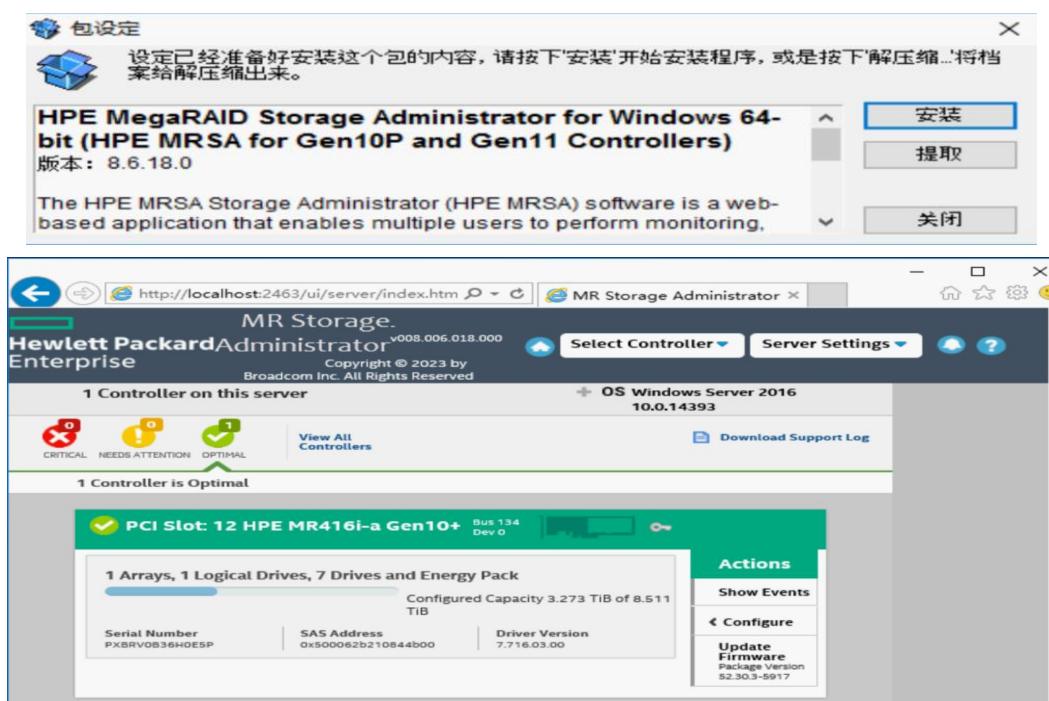
(4) 降至未涉及当前公告的版本，可以正常访问

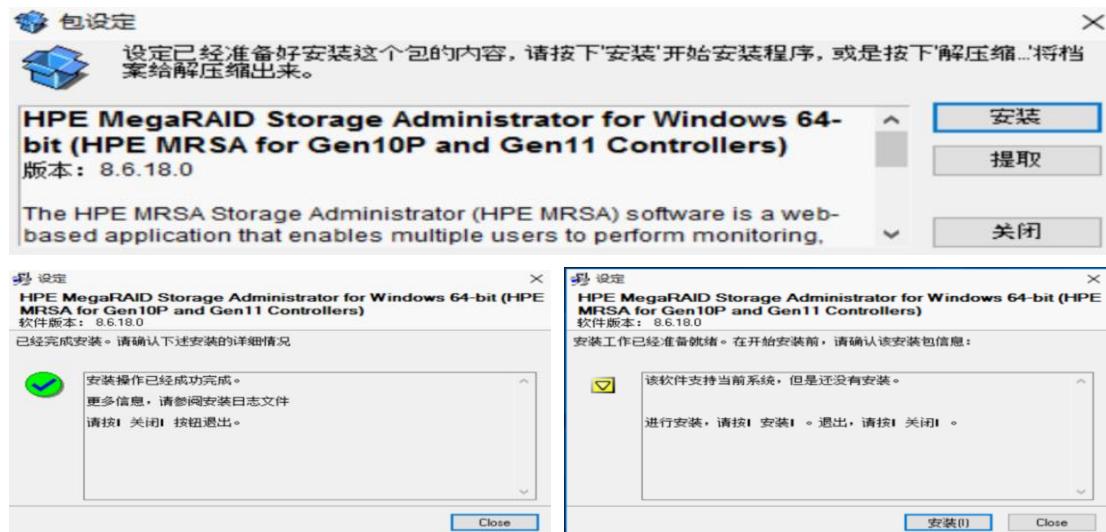
(5) 再次升级至问题版本触发蓝屏后，尝试回退，安装低版本 MRSAs 软件工具，安装提示成功，但是系统中查找不到该软件，且再次点击安装的时候会提示仍未安装。

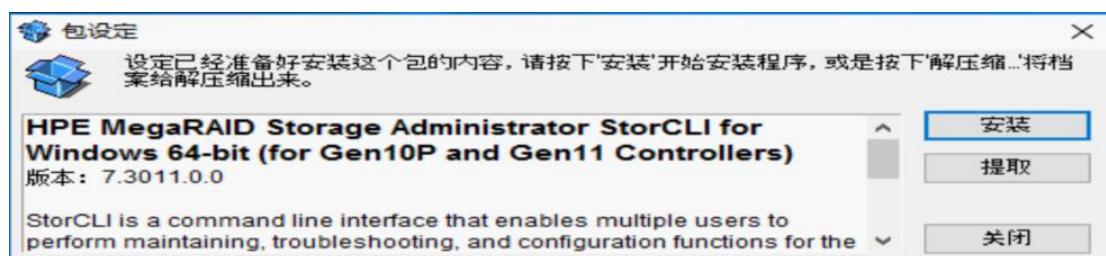
(1) 未开启软 RAID 或开启但未安装 S100i 驱动的情况下，安装涉及公告版本的 StorCLI，可以正常使用

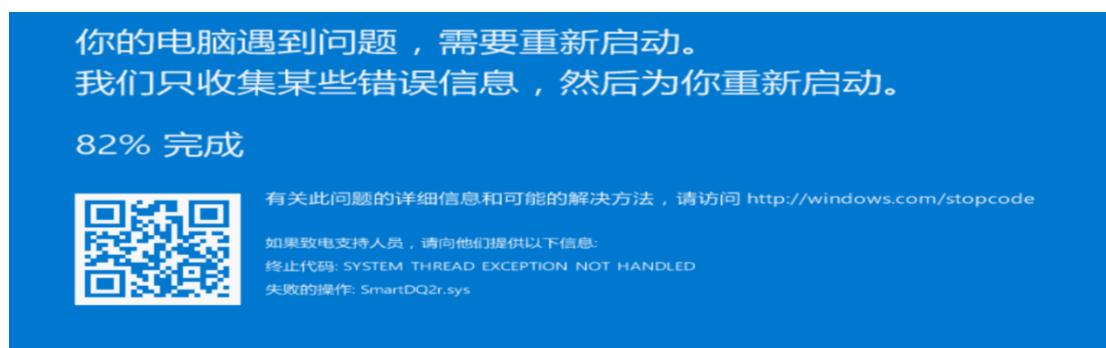
(2) 开启软 raid 并安装 S100i 驱动后，再次使用涉及本次公告版本的 StorCLI 时，系统会触发蓝屏，服务器会自动重启。

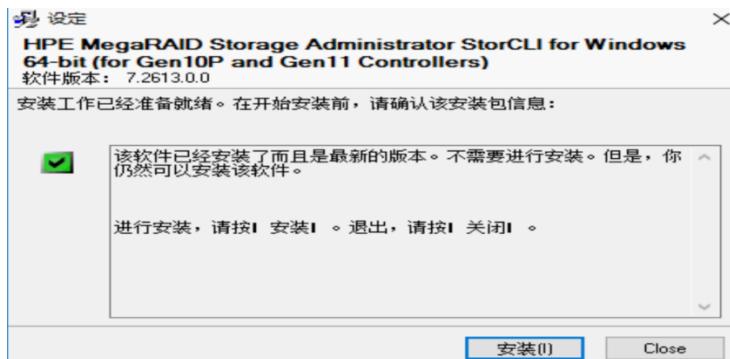
(3) 重启后可以进入到系统中，将 StorCLI 版本降低回之前的版本，仍可以继续使用，无

需重新安装系统。

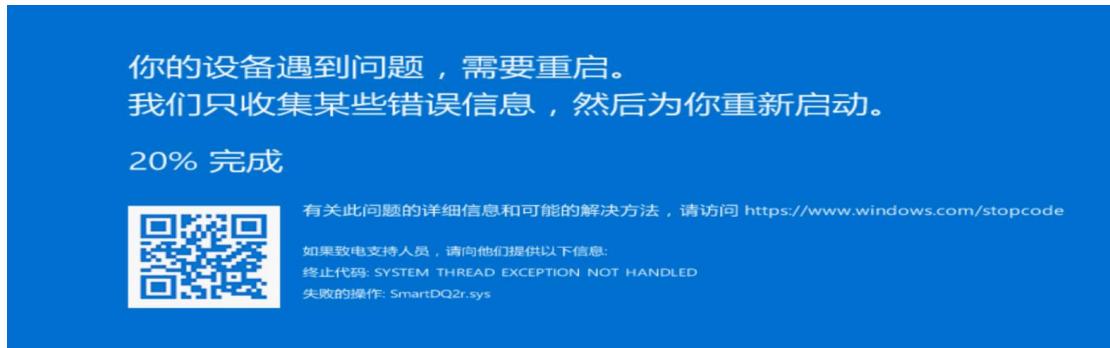
- (2) 刷新过程中，系统会触发蓝屏自动重启

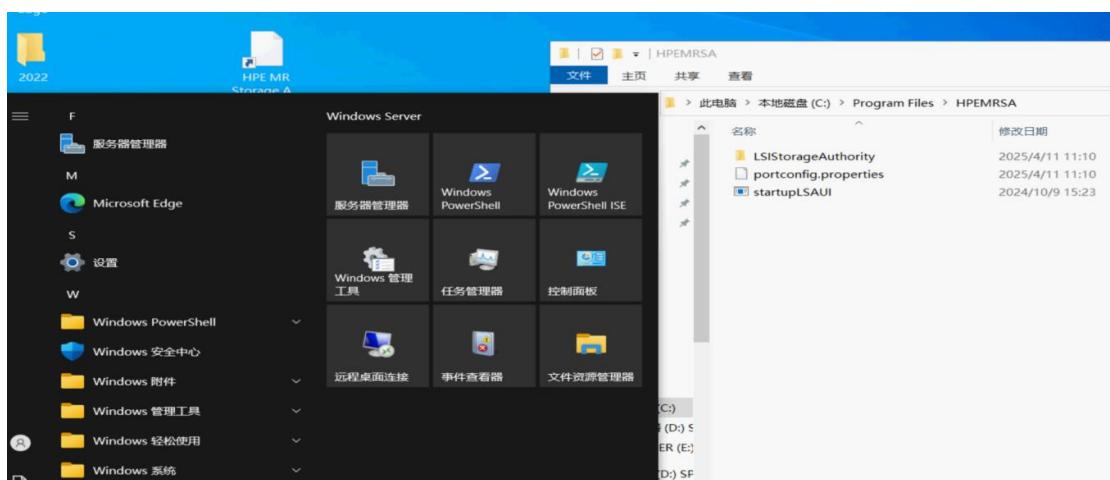
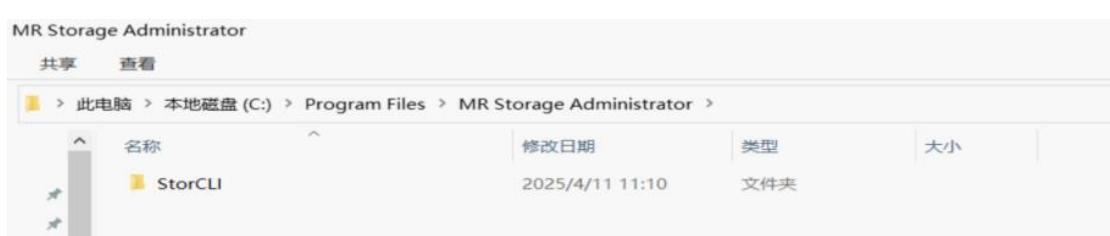
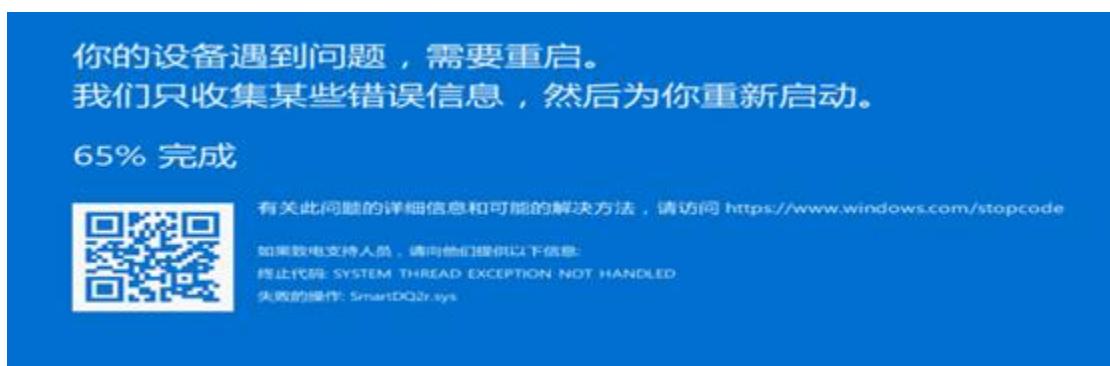
(3) 重启后，发现 MRSA 软件没有安装成功，StorCLI 工具是安装成功的，尝试使用 StorCLI，会立即触发蓝屏。

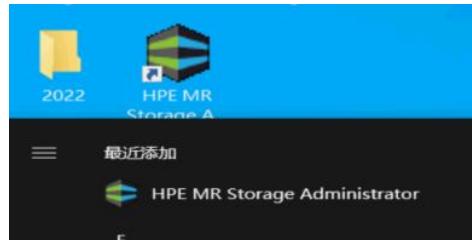
1) 将安装的涉及问题版本的 MRSA 文件夹删除，尝试安装低版本 MRSA，可以安装成

功。

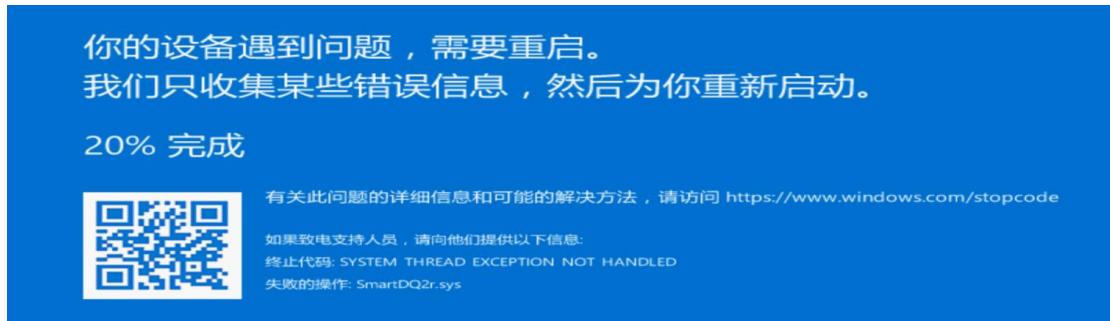
(3) 将 MRSA 软件再次升级至涉及该公告问题的版本，则会再次触发蓝屏

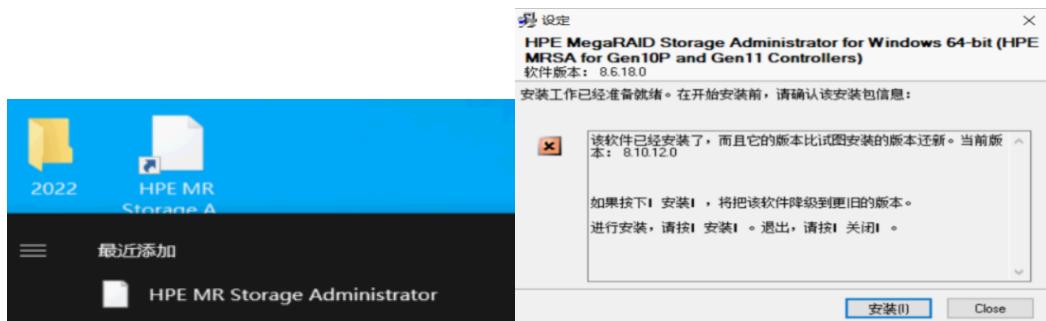
(4) 不删除当前安装的软件，强制刷至低版本 MRSA 软件

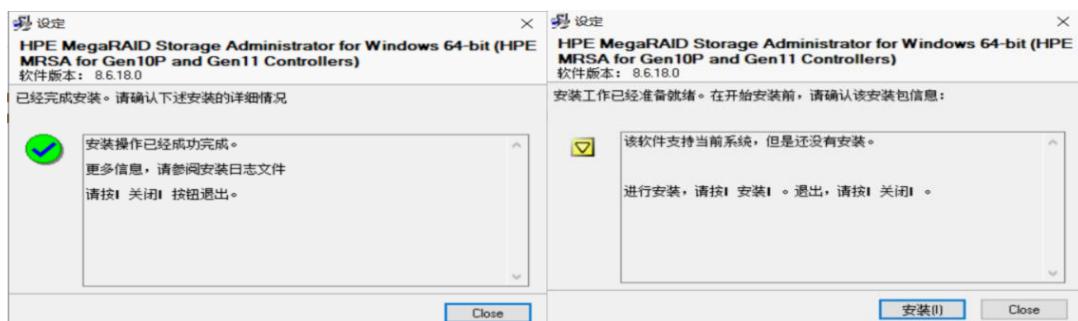
(5) 提示安装成功后，未发现安装成功的软件，再次点击安装会提示当前没有安装该软件。需要重新安装系统解决。（反复测试过现象一致）

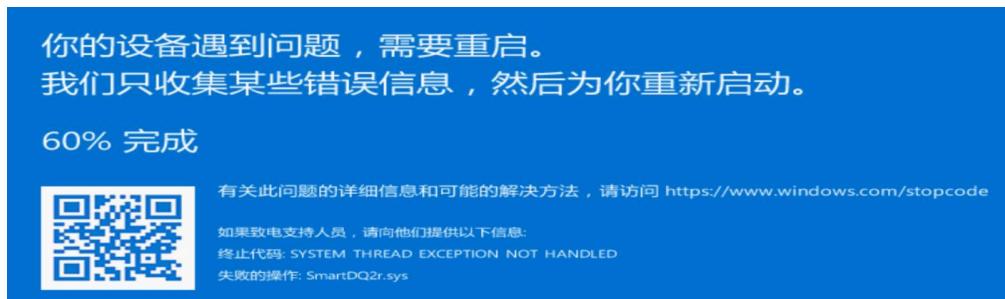
(2) 再次尝试安装最新版本工具，安装后运行时会触发蓝屏

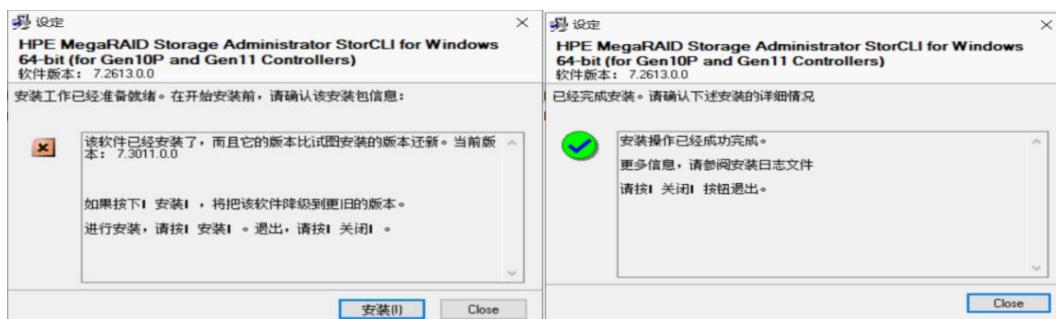
(3) 不删除当前工具，强制刷新低版本工具，可以正常使用，不会触发蓝屏。

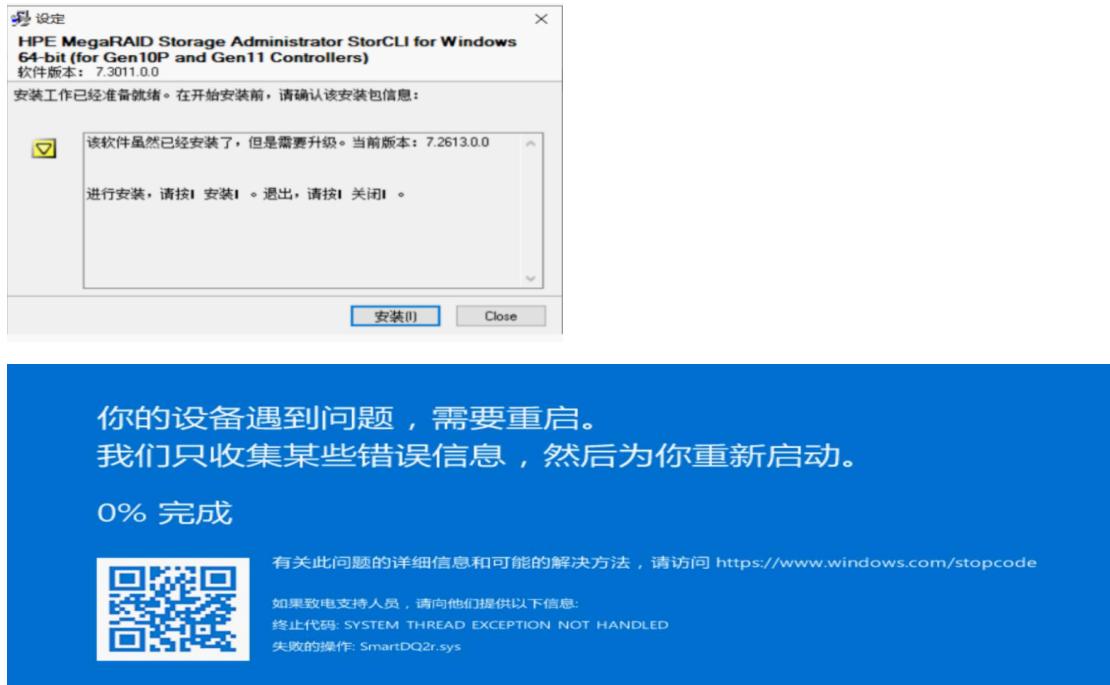
(4) 再次升级工具版本至最新，触发蓝屏

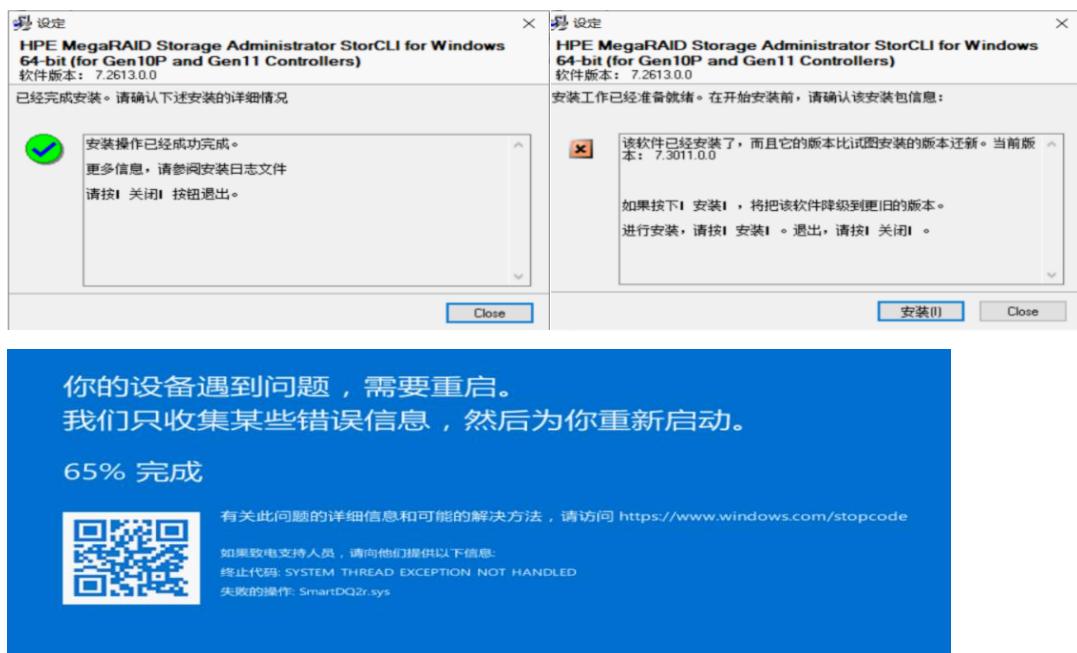
(5) 再次尝试将 StorCLI 工具降至原来低版本，发现虽然提示成功但是再次点击安装，仍会提示当前为高版本，且运行会蓝屏。

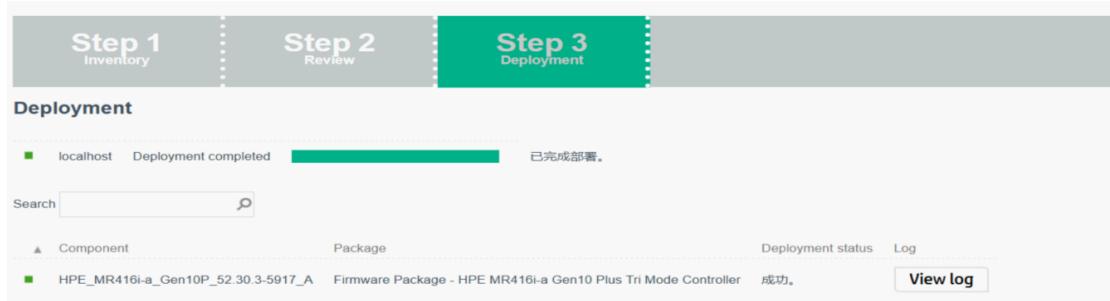
4、SPP 包升级阵列卡固件，系统无异常
