知 某局点S7506E对接华为设备聚合起不来

二层链路聚合 吴虹 2020-02-26 发表

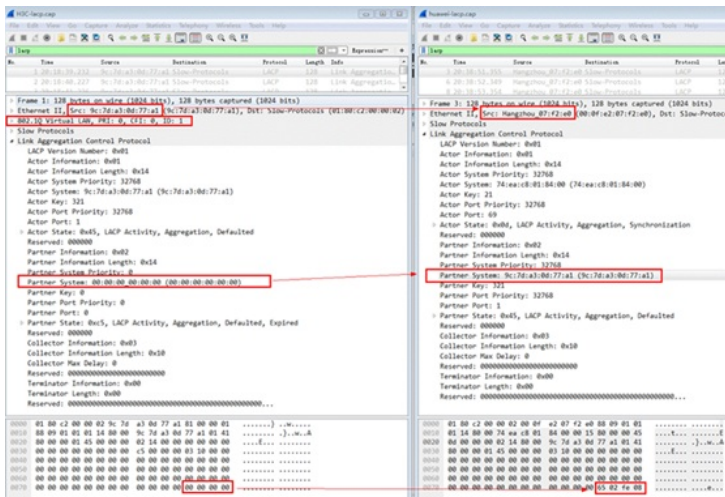
在两端设备上分别抓包，发现S7506E发的LACP报文的最后4个字节FCS为6502fe08，和華為侧发的LACP的报文的最后4字节的FCS值不一致，导致華為侧丢弃该LACP报文，聚合无法对接。

使用计算FCS的网站计算出来的LACP报文的FCS应该是E2CD4C40，而设备发的LACP报文的FCS为6502FE08。

最后，经过本地复现及抓包对比分析，发现如果配置了如下命令后，设备发送的lacp报文会增加4个字节，即：6502FE08。

因为设备上配置了该命令，导致聚合无法成功，同时在设备配置手册中对于该命令有如下描述：开启全局的聚合流量重定向功能时，如果有连接其它厂商设备的聚合接口，可能影响该聚合组的正常通信。

所以取消该命令后，聚合正常建立。

undo link-aggregation lacp traffic-redirect-notification enable。

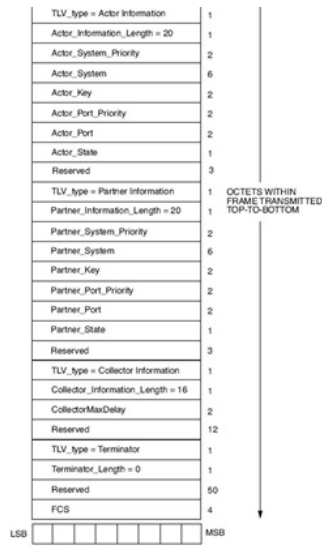
Figure 43-7—LACPDU structure

但是我司设备和華為为设备对接动态聚合的案例有很多，而且对接起来完全没问题，查看 LACP 的 RFC 标准文档：一个 LACPPDU 报文长度包含 FCS 校验，应该是 128 字节，最后 4 字节应该是 FCS，用来校验报文的 MAC 层信息，即如果 FCS 校验不通过，对端 MAC 层就会过滤掉，端口上会有 CRC 错包。当时在对端设备接口上也并没有 CRC 错包，并不能说明报文发的有问题。

NOTE 2—These trailing reserved octets are included in all valid LACPDU in order to force a fixed PDU size of 128 octets, regardless of the version of the protocol. Hence, a version 1 implementation is guaranteed to be able to receive version N PDUs successfully, although version N PDUs may contain additional information that cannot be interpreted (and will be ignored) by the version 1 implementation. A crucial factor in ensuring backwards compatibility is that any future version of the protocol is required not to re-define the structure and semantics of information defined for the previous version; it may only add new information elements to the previous set. Hence, in a version N PDU, a version 1 implementation can expect to find the version 1 information in exactly the same places as in a version 1 PDU, and can expect to interpret that information as defined for version 1.

ac) FCS. This field is the Frame Check Sequence, typically generated by the underlying MAC.
