知 某局点S7506E对接华为设备聚合起不来

二层链路聚合 吴虹 2020-02-26 发表

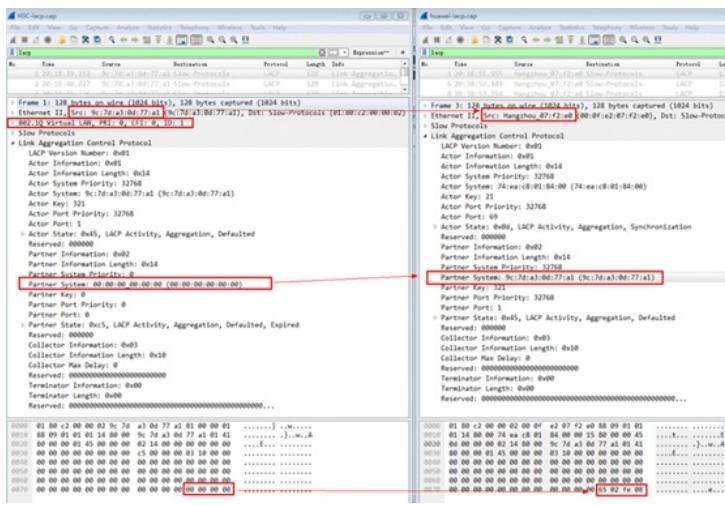
在两端设备上分别抓包，发现S7506E发的LACP报文的最后4个字节FCS为是6502fe08，和华为侧发的LACP的报文的最后4字节的FCS值不一致，导致华为侧丢弃该LACP报文，聚合无法对接。

undo link-aggregation lACP traffic-redirect-notification enable。

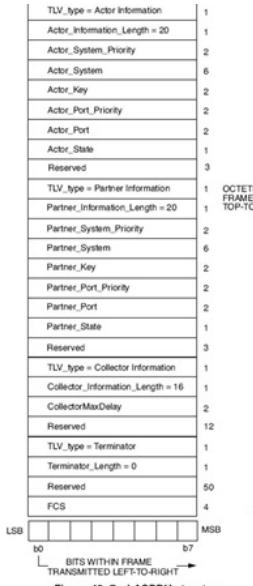
Figure 43-7 – LACPDU structure

但是我们设备和华为设备对接动态聚合的案例有很多，而且对接起来完全没问题，查看 LACP的RFC标准文档：一个LACPPUD报文长度包含FCS校验，应该是128字节，最后4字节应该是FCS，用来校验报文的MAC层信息，即如果FCS校验不通过，对端MAC层就会过滤掉，端口上会有CRC错包。当时在对端设备接口上也并没有CRC错包，并不能说明报文发的有问题。

NOTE 2—These trailing reserved octets are included in all valid LACPDUs in order to force a fixed PDU size of 128 octets, regardless of the version of the protocol. Hence, a version 1 implementation is guaranteed to be able to receive version N PDUs successfully, although version N PDUs may contain additional information that cannot be interpreted (and will be ignored) by the version 1 implementation. A crucial factor in ensuring backwards compatibility is that any future version of the protocol is required not to re-define the structure and semantics of information defined for the previous version; it may only add new information elements to the previous set. Hence, in a version N PDU, a version 1 implementation can expect to find the version 1 information in exactly the same places as in a version 1 PDU, and can expect to interpret that information as defined for version 1.

ac) *FCS.* This field is the Frame Check Sequence, typically generated by the underlying MAC.
