知 S6800 堆叠分裂导致业务受到影响

堆叠 IRF2 翁青山 2020-02-28 发表

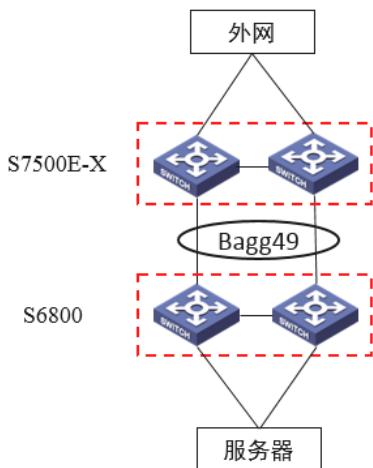
组网及说明

S7500E-X和S6800分别是两台设备做堆叠，都配置了BFD MAD，两组设备而之间通过跨框聚合组49进行互联。两组设备都开启了STP，S7500E-X是根桥设备。

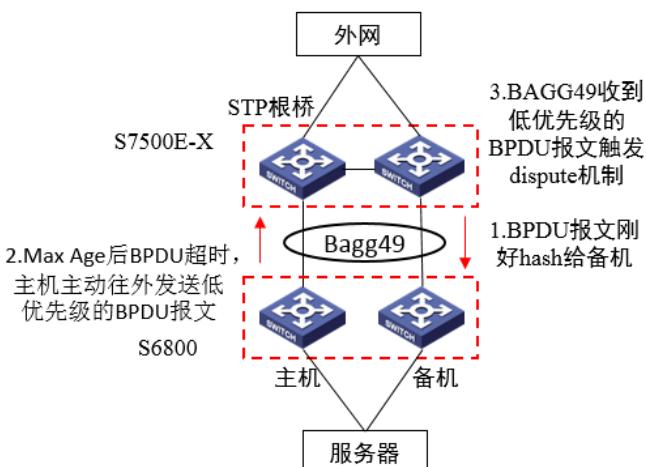
结合当前信息，怀疑S6800堆叠分裂时备机上的Bridge-Aggregation49及其对应的物理端口并未被mad
shutdown，导致分裂后S6800和S10500设备之间的聚合仍然正常。而S7500E-X作为根桥设备，只会
从Bridge-Aggregation49发送一份BPDU报文出去，可以判断该BPDU报文正好hash发送给备机，而主
机上一直没有收到BPDU报文，当定时器超时后S6800主机就主动发出低优先的BPDU报文，触发了S7
506E-X的dispute机制，从而导致S7500E-X的Bridge-Aggregation49被block进而影响到业务。

- 1、现场配置问题，在Bridge-Aggregation49排查BFD MAD VLAN解决。
- 2、V5版本BFD MAD检测接口不会自动作为系统保留接口，V5版本B70分支修改为BFD MAD检测接口自动作为系统保留接口，已提MUI需求让研发修改回去，避免后续出现类似问题。
