组网及说明

问题描述

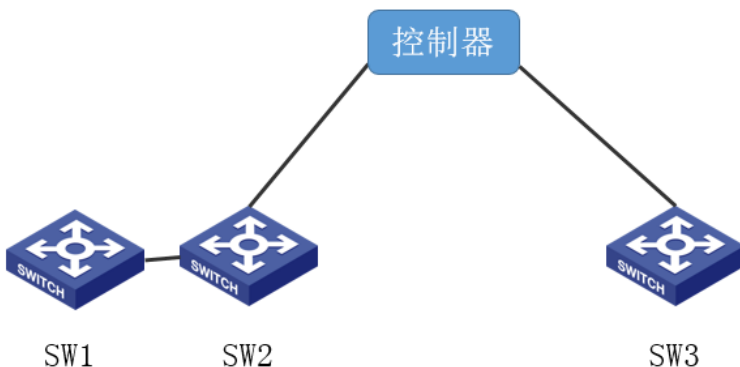
现场简化组网图如下，SW1和SW2堆叠，控制器连接交换机的管理口：

(2) 现场排查组网，在控制器上发现学到了两个相同的mac，经排查，同一个二层组网中，SW3和SW2/SW1的管理口mac地址是一样的。跟现场了解情况，现场在开局组网之前，将SW2和SW3堆叠在一起测试过，之后直接在堆叠状态下拔掉堆叠线让两台设备堆叠分裂，没有重启。之后又将SW2和SW1堆叠，和SW3一起加入到组网中，结果SW3的管理口和堆叠设备的管理口mac相同。初步判断是因为堆叠时配置了mac永久保留，两台设备堆叠时，管理口mac同步了，之后堆叠分裂又没有重启，导致两台设备的管理口mac是一样的。

(4) 根据现场环境和实验室测试结果, 可以确定现场故障是由于二层组网中mac冲突导致的, 而mac冲突是由于堆叠设备分裂后, 因为配置了mac保留, 导致管理口mac保持和原主框一致造成的。

将分裂后的备设备 (SW3) 重启后, 重新生成了新的mac, 地址冲突解决。
