Technical announcement on H3C UniServer rack server CNA-560T-B2-10Gb-2P network card which is unable to LINK UP under partial version on VMware ESxi system

Servers 孟普 2020-05-21 Published

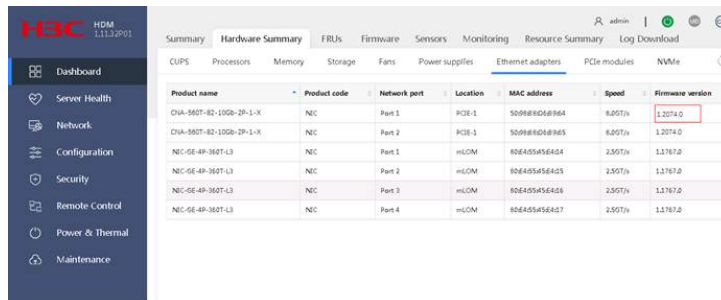
CNA-560T-B2-10Gb-2P Firmware Version:1.00.1(Displayed under HDM and system as1.2074.0).

The following is the firmware version information for the 560T-B2 network card shown in HDM:

Upgrade the firmware of the CNA-560T-B2-10Gb-2P network card to version 2.00.0 on the official website.

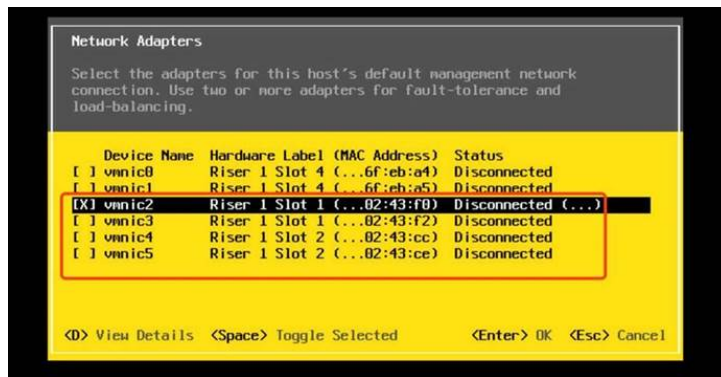
CNA-560T-B2-10Gb-2P network card cannot LINK UP during the use of VMware ESXi6.0 U3, VMware ESXi6.5/ 6.5 U1/6.5 U2 systems.

Console F2 network configuration items are shown below:

The FLASH module in the firmware of CNA-560T-B2-10Gb-2P network card version 1.00.1 (HDM and system display 1.2074.0) has a matching problem with VMware ESXi 6.0 U3, VMware ESXi6.5/6.5 U1/6.5 U2, which causes the network card to fail LINK UP during system use.
