# VCFC控制器无法下发虚拟负载均衡问题

版本信息：

VCFC E2180P26

L5000C 8130P30

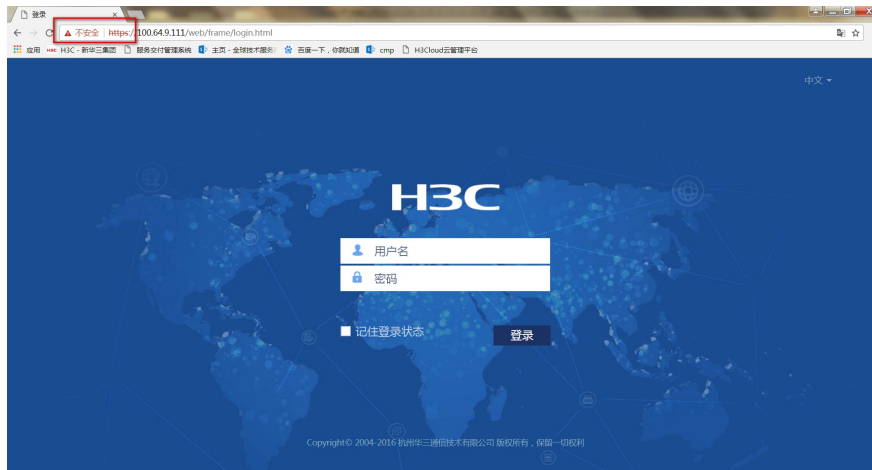
(1) 通过https方式登录安全设备的web界面，点击“不安全”；

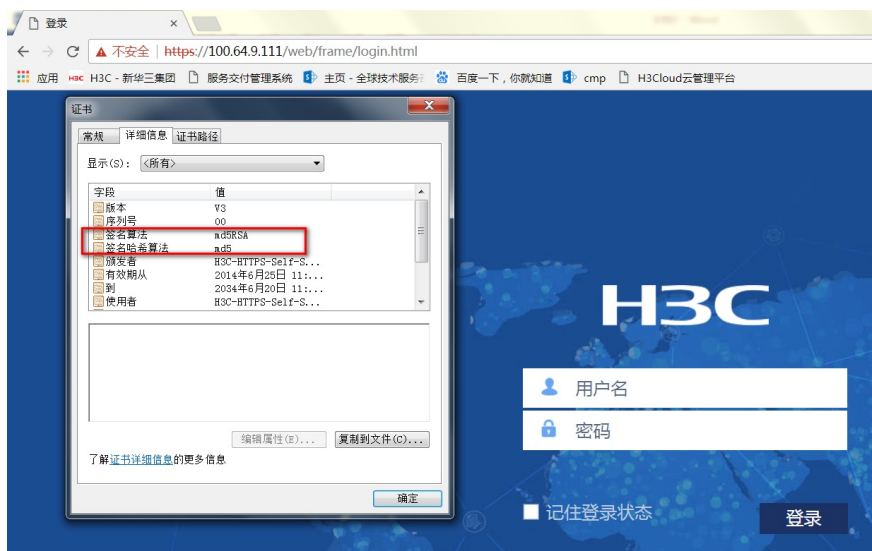
(2) 点击“证书—详细信息”，如图所示，可看到该设备采用了md5RSA算法；

3、由于该设备是从较老的版本升级上来的，在升级过程中设备证书未更新，仍采用md5算法，因此不能被VCFC纳管。

1、Telnet登录L5000-C设备，使用dir命令查看设备文件，进入pki目录并删除该路径下的https-server.p12；
