某局点S7500E 与S5600链路聚合状态错误 案例分析

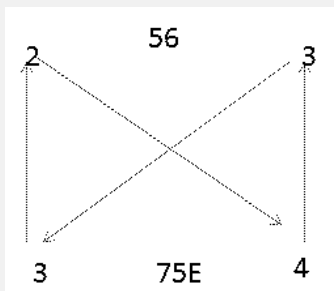
但从debug信息来看, 两侧设备收发LACP报文的端口与实际端口不一致。

应该是光纤连接交叉了。具体如下示意图:

S7500E的port ID 3收到的是S5600的3发过来, 所以回的报文是S7500E 3-> S5600 3 (但实际发给了S5600的2)

S7500E的4收到的是S5600的2发过来, 所以回的报文是S7500E 4-> S5600 2 (但实际发给了S5600的3)

S5600的2收到的是S7500E的3发过来, 所以回的报文是S5600 2-> S7500E 3 (但实际发给了S7500E的4)

S5600的3收到的是S7500E的4发过来, 所以回的报文是S5600 3-> S7500E 4 (但实际发给了S7500E的3)

经过排查现场光纤连接情况, 发现确实是光纤交叉连接导致了这个现象。
