The server failed to expand into UIS cluster after replacing the motherboard

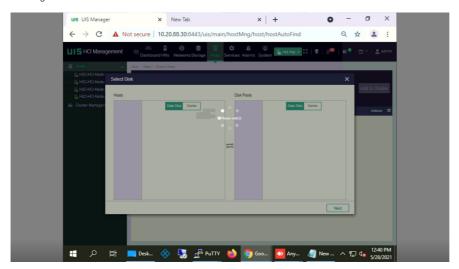
Scaling cannot see the disk for the new node

It is found that the product name layer of this node is UIS-Cell-3000. This is because the UIS-Cell-3000 G3 servers are all modified from R4900 G3. Therefore, after replacing the motherboard, new information needs to be burned to the motherboard

To burn UIS-Cell-3030 to a new motherboard, find the "Server Modifying Device Name Guide" in the UIS Version Guide and use the tool ipmitool. exe to burn the server name.
