某局点S7503X IRF环境下挂2个终端三层互访不通的经验案例

策略路由 张腾 2021-09-26 发表

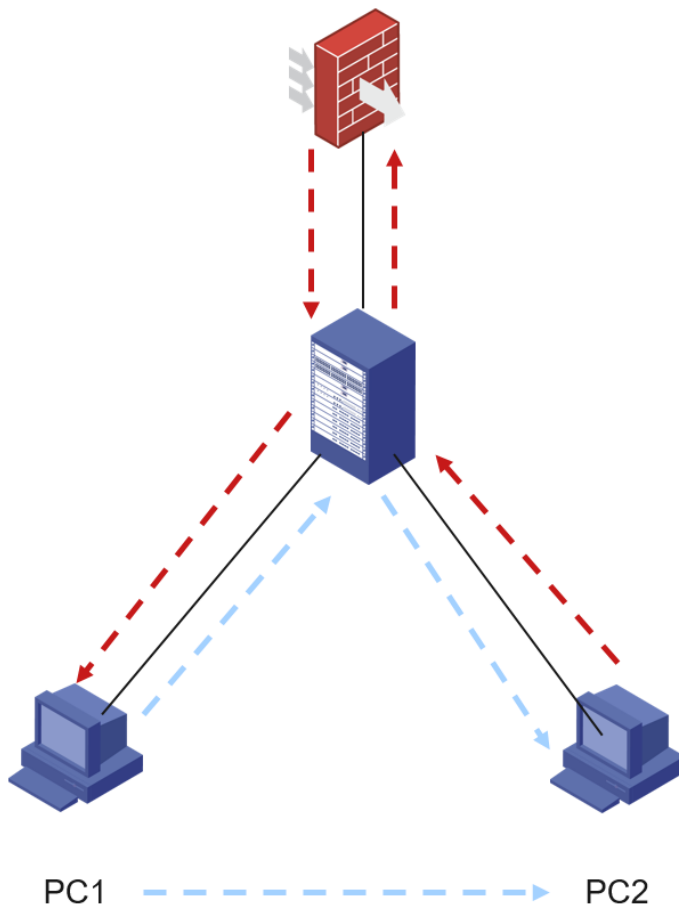
如图2台S7503X做IRF作为2个终端的网关，PC1和PC2不同网段。PC1访问PC2的流量，去方向直接通过交换机发往PC2，PC2的回城流量通过策略路由引到第三方准入设备后再发给S7503X，然后发给PC1。

PC1访问PC2不通

4. PC2的网关接口配置了PBR，下一跳出接口就是1/2/0/26口。正常情况下从准入发过来的三层流量
不会再匹配PBR，但从现象看从准入发给S7503X的报文又匹配了PBR。将网关接口的PBR配置删除后
，出接口正确，PC1和PC2能够正常通信。

改成MQC实现需求:
