知 某局点S12500交换机多块业务单板状态为off问题排查经验案例

产品特性 其他硬件相关 赵跃 2017-05-20 发表

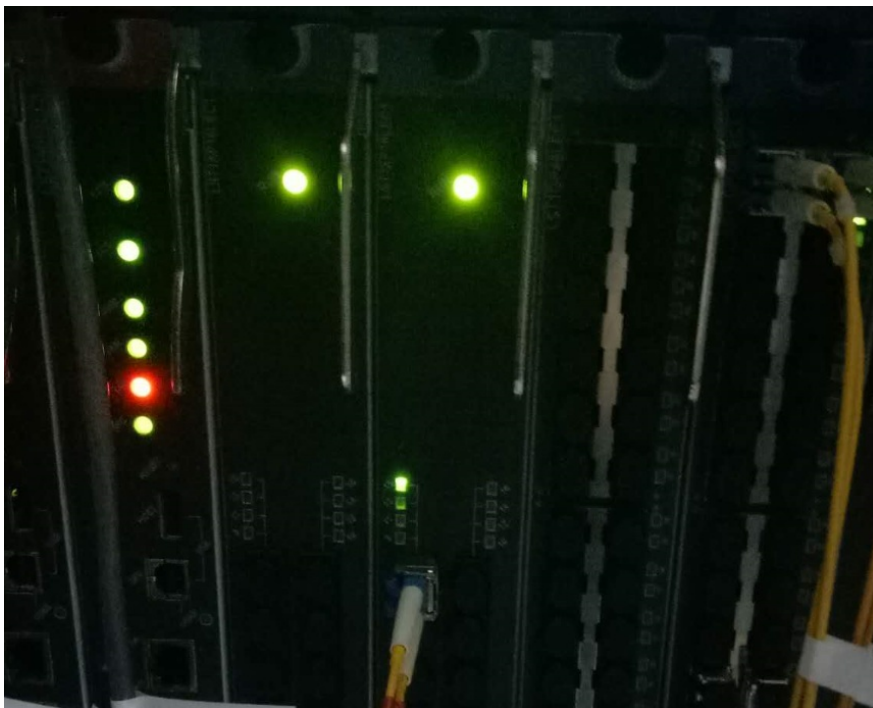
客户现网有两台独立的S12508设备，一台设备一块接口板状态为off，另一台设备两块状态为off。主控板上该接口板状态指示灯亮红灯。两个机框三块接口板重新插拔后，单板注册正常，状态变为正常的normal。

从上述日志信息可以确认，两台设备单板off状态原因为人为执行命令手工下电导致，单板无硬件故障

- 1、可通过手动拔插单板，单板重新上电注册恢复；
- 2、可通过在用户视图下执行命令：power-supply on slot X恢复；
