知 F1000-AK155(V7) 报文捕获失败

内存 彭钦 2021-12-27 发表

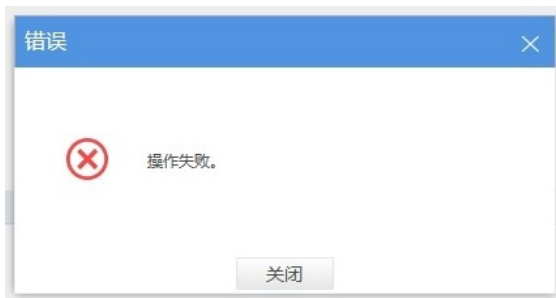
web抓包报错：操作失败 命令行抓包报错：failed to start packet capture

[F1000]packet-capture start acl 3999
The operation will delete .cap files in storage path, continue?[y/n]
Failed to start packet capture.
```

这个日志表示内存申请失败

升级到官网最新版本解决
