某局点S7506E下组播接收者无法接收组播视频流的经验案例

PIM 丁佳欣 2022-01-04 发表

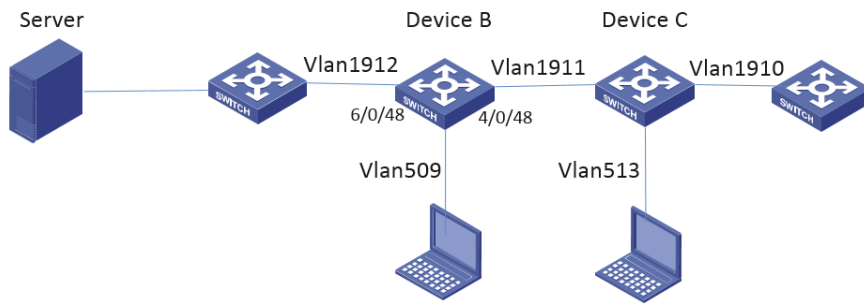
组网及说明

device B和device C下的用户无法接收到组播视频流量。

现场有组播的视频业务，经过一系列中间设备后device B和device C下的用户无法接收到组播视频流量，组播采用的是PIM SM的方式。

组播源修改后解决。
