# CAS添加共享存储卷失败之错误码5106

芮恒 2022-01-26 发表

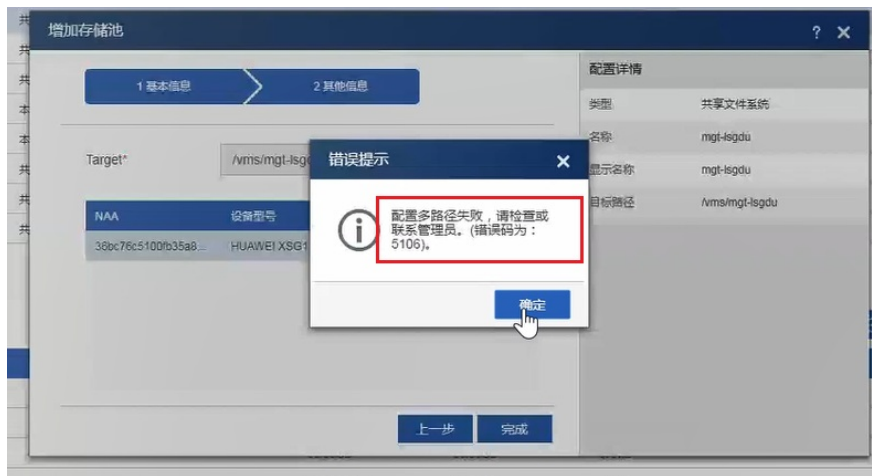
现场主机可正常识别该FC存储卷，但执行添加时报错配置多路径失败，错误码5106

1、后台查看syslog系统日志，可以看到LUN信息改变而未自动更新的打印，判断可能和udev未自动更新有关，前后台共享存储卷记录信息不一致会导致配置存储多路径时无法正常识别该存储卷。

- 1、主机后台执行udevadm trigger更新udev信息
- 2、前台重新启动挂载存储卷
