知 某局点WX3540X 云简平台固定账号登录失败

绿洲平台 王姑娘 2022-03-12 发表

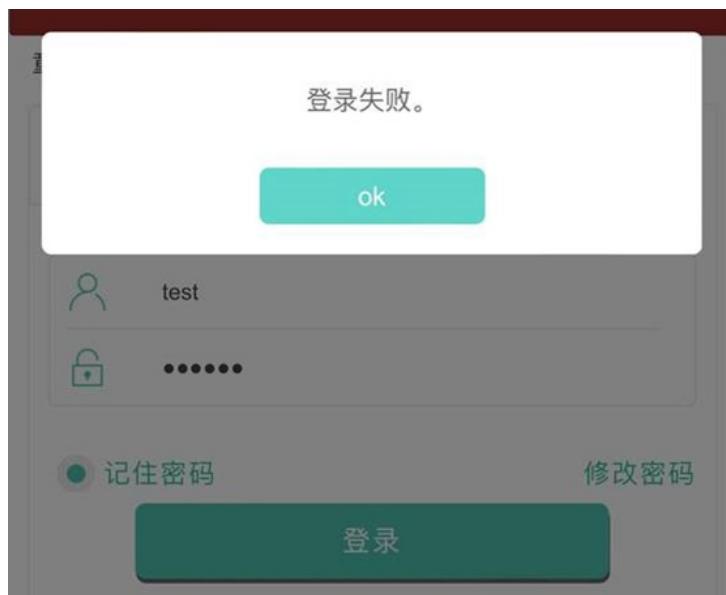
现场按照官网的云简平台认证手册实施开局，配置大部分都是云简平台下发的。做的固定账号认证，目前可以弹出认证界面但是无法认证成功，输入账号和密码后登录，提示登录失败。

#
ip http port 8088
#
portal local-web-server http
tcp-port 8088
但测试后故障依旧
3、检查AC 本地与云简网络互联的TCP连接信息，发现异常：
[3540X] display tcp verbose | b portal
.....
Creator: portald[5679]
State: ISCONNECTED
Options: SO_SEQPACKET
Error: 0
Receiving buffer(cc/hiwat/lowat/drop/state): 14105114 / 130560 / 1 / 0 / N/A
Sending buffer(cc/hiwat/lowat/state): 4273052596 / 131070 / 512 / N/A
Type: 1
Protocol: 6
Inpcb flags: INP_ANONPORT INP_SYNCPCB
Inpcb extflag: N/A
Inpcb vflag: INP_IPV4
TTL: 255(minimum TTL: 0)
Connection state: ESTABLISHED
TCP options: TF_NODELAY TF_REQ_SCALE TF_RCVD_SCALE TF_REQ_TSTMP TF_SACK_PER
MIT
NSR state: CLOSED(M)
Send VRF: 0x0
Receive VRF: 0x0 Connection info: Src =101.202.6.3:16270, Dst = 101.36.161.143:443 //AC 与错
误的云简网络IP和端口建立了连接
通过上述查看，已找到故障的原因。AC与错误的云简网络IP和端口建立了连接。目前正确的云简网络I
P地址端口应该为：101.36.161.146:80。

h.h3c.com/portal/protocol
if-match original-url http://o2o.gting.com/wifi/echo temp-pass redirect-url http://oasisauth.h3c.com/ge
解决方法
在原有AC的配置基础上http://www.apple.com指定域名对应的正确IP地址重写AC后问题解决。

#http://oasisauth.h3c.com/portal/protocol
dns server 119.X.X.X
ip host local-web-server comp 101.36.161.146 //增加相关配置
#
portal local-web-server https
#
ip http enable
ip https port 8668
ip https enable
