# 某局点S6520X-EI跨框聚合组播流量不hash

PIM 二层链路聚合 许家豪 2022-03-17 发表

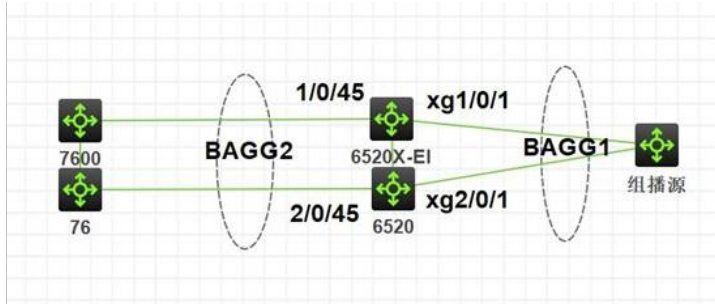
组网如下图：

问题描述: 两台6520做堆叠, 设备开启PIM-SM跑组播流量, 流量从聚合口1进入, 从聚合口2发出, 但是聚合口2中只有一个链路Ten1/0/45口有流量

问题原因: 已知组播报文出接口为聚合接口目的报文的转发是单播转发, 本地优先转发对已知单播报文转发, 因此本地已知单播报文生效目的地址之向不同物理接口进行聚合转发, 没有实现负责分担。因此, 关闭本框优先转发可实现流量hash转发

关闭本框优先转发 (undo link-aggregation load-sharing mode local-first)后, 流量可正常hash
