知 S10508-V配置本地镜像后显示资源不足

交换机型号: S10508-V

涉及版本: (V7) Release 7557P03

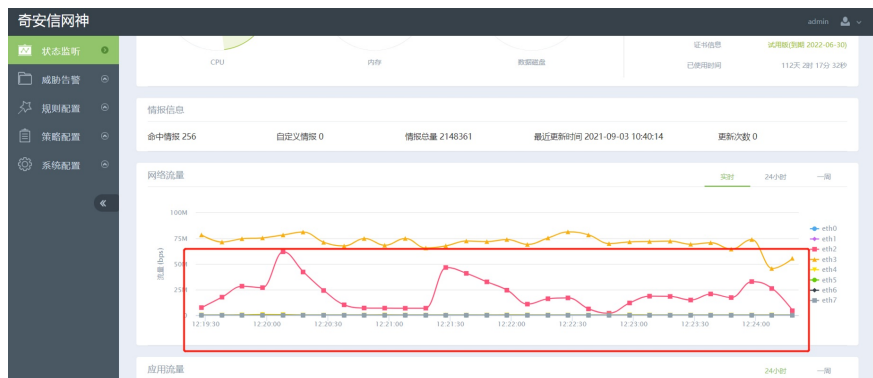
监控主机：

但是现场配置完成后：发现多个监控主机上的流量波动很大，一会几十兆流量，一会又到了0；但是监控口的300S的流量已经达到100%

查看配置发现vlan999是业务vlan，而现场把源接口G1/1/0/9也放通了业务vlan999。规范接口配置，只在目的镜像口放通业务vlan后。监控主机显示流量正常。
