某局点MSTP+VRRP组网 修改STP实例后端口异常阻塞问题

STP VRRP 倪民 2022-12-02 发表

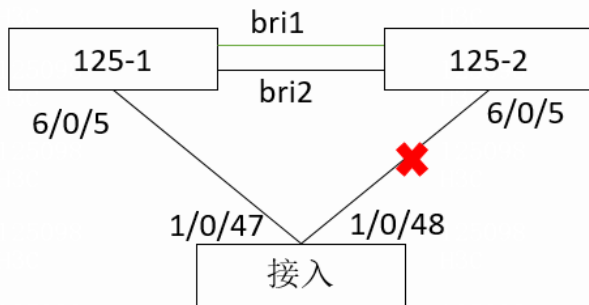
组网如下，两台S125设备作为汇聚，启用VRRP，BAGG1放通VLAN710（属于逃生用VLAN），默认属于instance0，BAGG2放通其他所有业务VLAN，划入instance1。

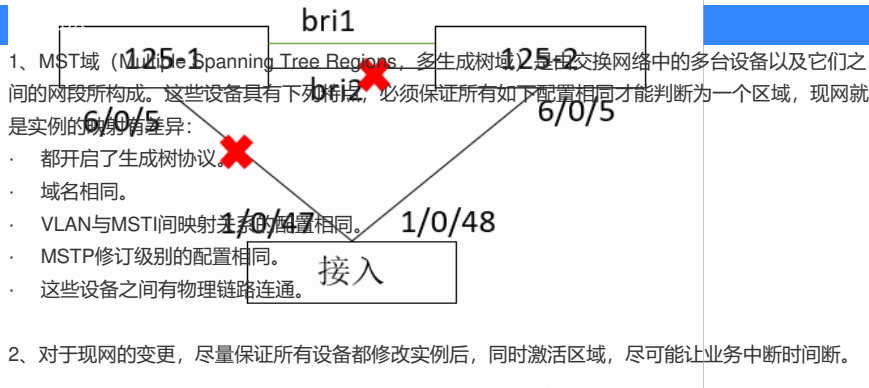
3、查看stp状态发现，S125-2设备实例1中横连的BAGG2被阻塞

4、接入设备上，连S125-1的接口被阻塞，连S125-2的接口放开

5. 在上面的情况下，两台S125的VRRP无法交互，产生双主。下面的业务只能从接入访问S125-2，但是S125-2上面的防火墙是备，无法转发流量，业务中断。

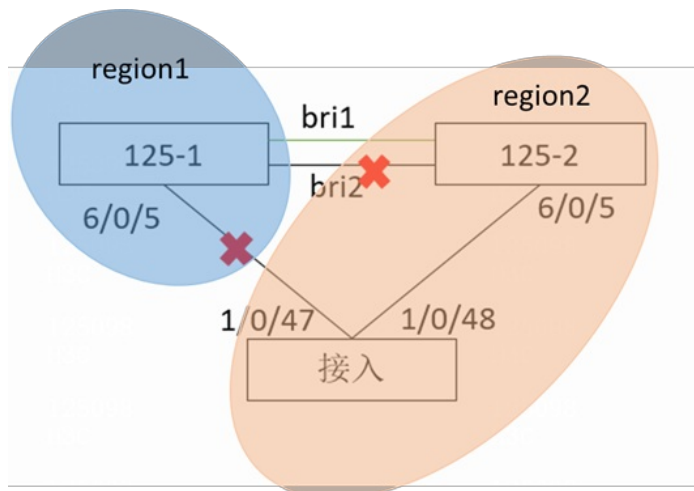
6. 对于这个问题，分析是新增VLAN110划入实例1后，导致S125-1和另外两台设备的stp区域配置不一致，所以相当于划分成了两个stp区域，需要进行MSTP多域的计算。

7. 区域1内只有S125-1设备自己，三个接口都是和区域2互联的接口，需要计算CST。区域2内，S125-2和接入之间计算MSTI0 (IST) 和MSTI1，S125-2作为区域2的根，所以6/0/5口和1/0/48口都是转发状态，分别是指定和根端口。

8. 接下来则是区域间的CST计算 (CST的计算是不考虑实例的)，全局的总根是S125-1设备，所以S125-1设备上BAGG1、2和6/0/5口都是指定接口，并转发。

而区域2的三个接口则需要进行选择，其中BAGG1作为master接口，BAGG2和1/0/47口则被阻塞，由于是CST没有实例的概念，所有导致BAGG2和1/0/47口实例0和1都被阻塞。
