知 过传输网P2P无法建立ospf邻居

OSPF 郭尧 2023-01-29 发表

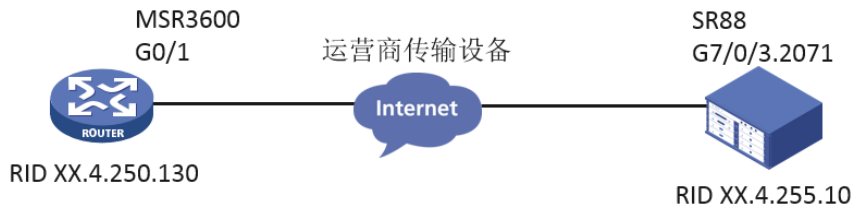
组网如上

问题描述: 现场MSR36与两个88建立ospf邻居, 网络类型是P2P, 与主88建立的ospf邻居建立不起来

因为ospf邻居配置不检查网段，只跟其相连的建立邻居，中间交换网是有问题的，MSR那边应该能收到98这边多个网段的ospf邻居报文：先收到谁就以谁来建邻居了，两端都配置一下 peer-add

peer-address-check 配置建立邻居关系必须在同一网段的检查功能，即在接收Hello报文时，对端的地址与当前接口地址必须同一网段

因此这里通过检查网段信息，可以在两端设备上规避掉这个中间交换网有问题的现象。
