# 某局点S125R BGP路由聚合问题

BGP

设备型号及版本: S12504R R3608

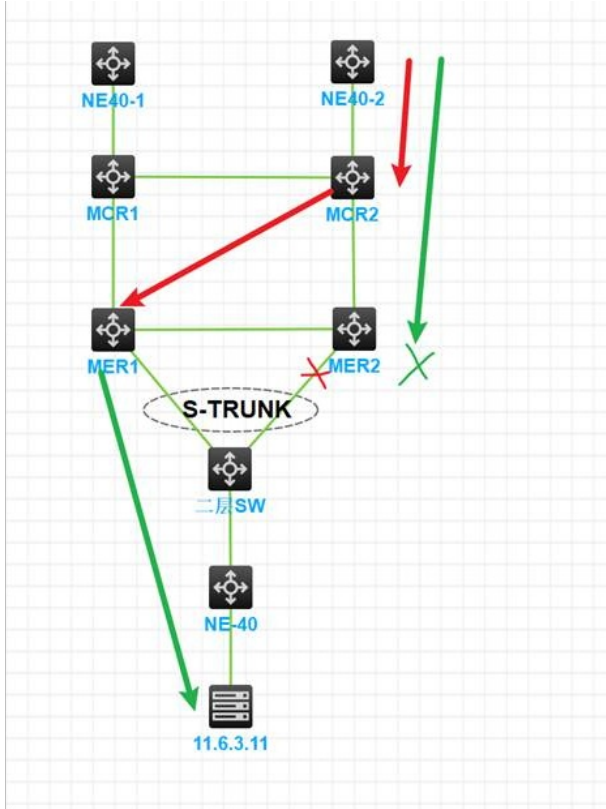
125R设备作为MER设备, 现场想要精简路由规格, 因此在两台125R设备BGP视图下的ipv4地址族做路由聚合, 发现聚合后右侧NE40-2设备访问server不通了, 原因是MCR-2上路由指向MER2, MER2上路由指向黑洞, 所以不通; 红色为正常流量走向, 绿色为不通时走向。

初步分析为: MER设备对接大二层交换机时使用S-trunk功能, 即两台MER只有其中一台设备上存在用户路由信息, 另外一台设备不存在用户路由信息。如果做路由聚合, 则两台设备都会向MCR发送聚合后的路由信息。导致寻址出现问题。

由于做了路由聚合, 则此时MER2也向MCR宣告路由, 则寻址不正常

聚合掩码错误导致,错误地把上行MCR过来的路由也并到一起了,导致我们认为本地都有明细路由,所以此时聚合后的16位掩码路由直接置为黑洞了.

修正配置后解决.
