交换机接口开启ARP代理导致直连设备不通的问题

ARP M-LAG/DRNI 杨坤 2023-07-25 发表

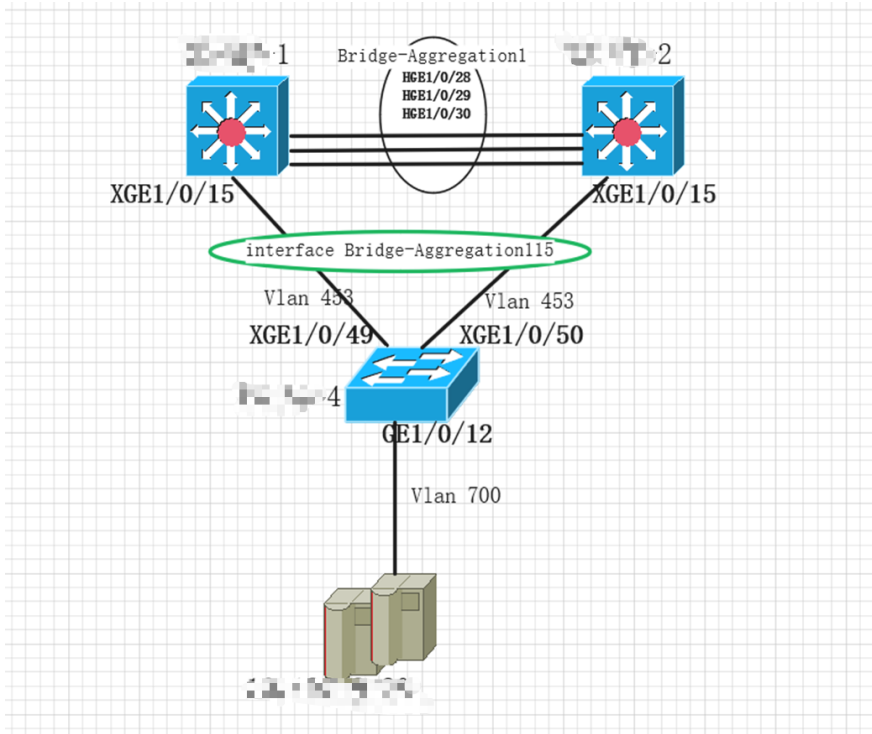
拓扑图中1号交换机和2号交换机 M-LAG组网对接下连4号交换机，现场问题现象是2号交换机无法ping通下连的4号交换机。

M-LAG编号为2的交换机ping下连编号为4(10.192.8.20)的交换机 ping不通，在编号为2交换机上查看学习下连交换机的ARP表项是发现从二层聚合组1中学习到的，并不是直接学习，学习到的MAC地址也不是真实的MAC地址。

发现编号为2的交换机学习的ARP表项异常，并非直接学习的。删除从BAGG1中学习到下连设备的ARP表项后又发现2号交换机又能够直接学习到下连设备的ARP表项，且学习到的MAC地址有变化，ping测试无问题。

但过了一段时间后2号交换机又ping不通4号交换机，发现学习到的MAC都不是设备的实际MAC，怀疑该现象与ARP代理相关。

将接口ARP代理关闭掉后恢复正常。

将交换机接口的arp代理功能关闭后ARP表项学习正常，编号2交换机ping编号4交换机测试正常。
