组网及说明

MSR3640和S5560替换思科设备，发现OSPF邻居卡在ExStart状态。

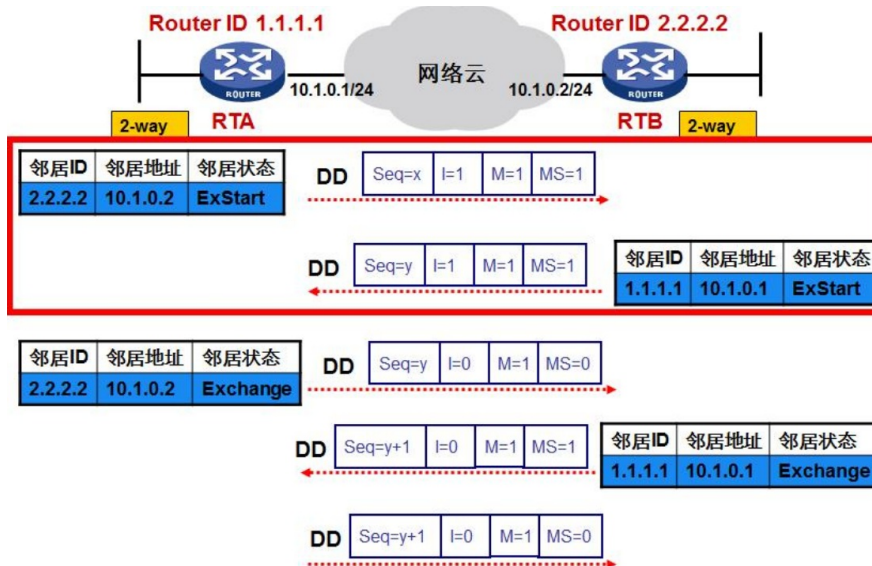
MSR3640收到并回复了DD报文，但是S5560上未收到。

根据OSPF邻居的建立过程邻居状态从ExStart到Exchange需要交互一次DD报文。由于MSR3640回复的DD报文S5560未收到，导致OSPF邻居卡在ExStart状态，测试MSR36与S5560直连，OSPF邻居正常full，经排查现场MSR3640和S5560之间还串接了一台二层加密设备，该设备将MSR3640回复的DD报文给过滤了。

协调中间二层加密设备进行配置修改，防止OSPF的DD报文被阻断
