🗯 某局点E528C-X交换机对接锐捷平台portal认证出现web界面认证失败

Portal **汪峻贤** 2023-11-30 发表

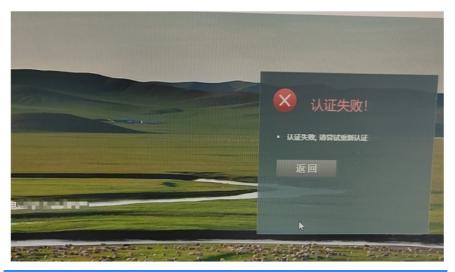
客户现场出现所有账号通过web做portal认证,输入用户名密码都显示认证失败

抓包查看交互过程发现ACK_Auth的ErrCode = 1,表示设备告诉Portal Server此用户认证请求被

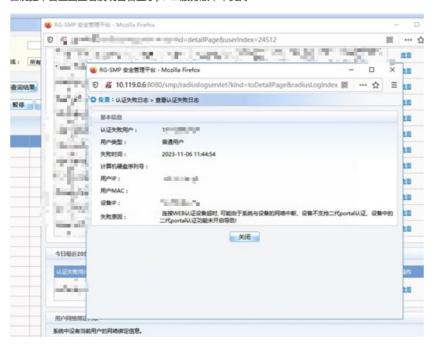
在锐捷平台上面查看发现告警显示portal服务版本不支持

我司设备portal对接锐捷平台时需要配置t=wireless-v2-plain这个参数用于标识二代web认证 需要加上这个参数
