组网及说明

问题描述

现场两台设备堆叠，ADDC自动下发方案，配置了openflow，但上线后openflow一直断断续续：

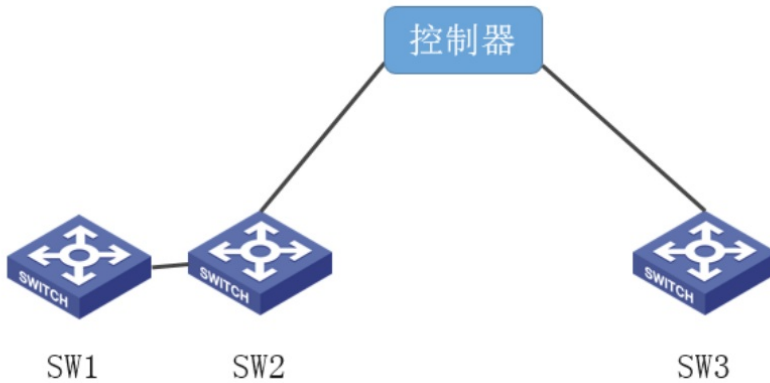
现场简化组网图如下，SW1和SW2堆叠，控制器连接交换机的管理口：

(2) 现场排查组网，在控制器上发现学到了两个相同的mac，经排查，同一个二层组网中，SW3和SW2/SW1的管理口mac地址是一样的。跟现场了解情况，现场在开局组网之前，将SW2和SW3堆叠在一起测试过，之后直接在堆叠状态下拔掉堆叠线让两台设备堆叠分裂，没有重启。之后又将SW2和SW1堆叠，和SW3一起加入到组网中，结果SW3的管理口和堆叠设备的管理口mac相同。初步判断是因为堆叠时配置了mac永久保留，两台设备堆叠时，管理口mac同步了，之后堆叠分裂又没有重启，导致两台设备的管理口mac是一样的。

(4) 根据现场环境和实验室测试结果, 可以确定现场故障是由于二层组网中mac冲突导致的, 而mac冲突是由于堆叠设备分裂后, 因为配置了mac保留, 导致管理口mac保持和原主框一致造成的。

重启sw3设备, 使mac重新刷新, 解决地址冲突
