DL380 Gen10  
使用 microsD RAID 1 USB部署VMware系统

问题描述

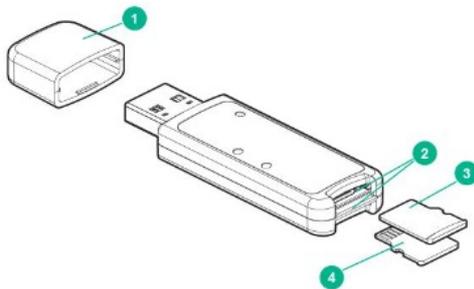
| Item | Description |
| 1 | Cap |
| 2 | MicroSD card slot |
| 3 | SD1 card |
| 4 | SD2 card |

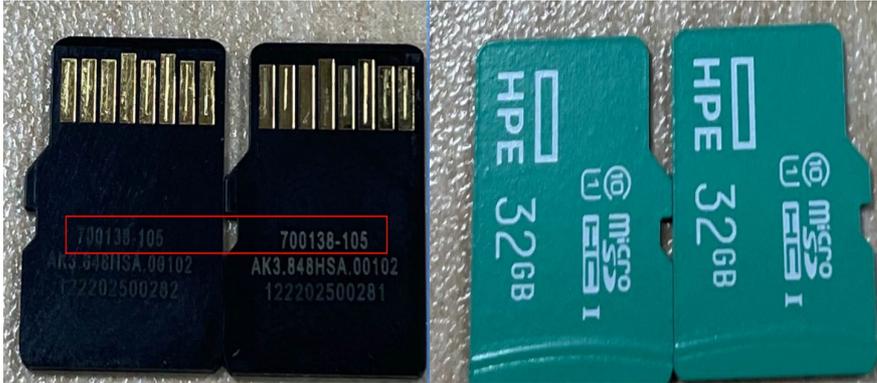
- 1、更换的SD卡的备件号必须和原来的备件号完全相同（若不同，则替换上去的SD卡不会进行重建）；

- 2、更换SD卡可以在线操作，若条件允许，替换上去的SD卡对应的指示灯开始红灯闪烁，表示正在进行重建，红灯熄灭表示重建完成（大约30分钟可以完成）；
- 3、microSD状态可以在ilo中查看（前提条件是系统下必须安装AMS服务），有SD卡故障或者正在重建，状态显示为黄色降级（如下），重建完成之后，状态变为绿色健康（若看到重建红灯已经不闪烁了，但是还是ilo中还是显示为黄色降级，可以重启下服务器恢复）：
