知 某局点t1000下联组播业务异常问题

域间策略/安全域 ASPF 攻击防范 陈泽勇 2024-05-29 发表

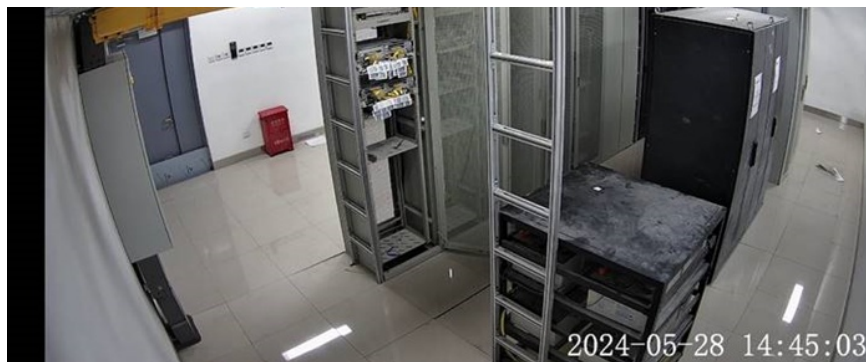
跳过设备直连核心交换机回显如下：

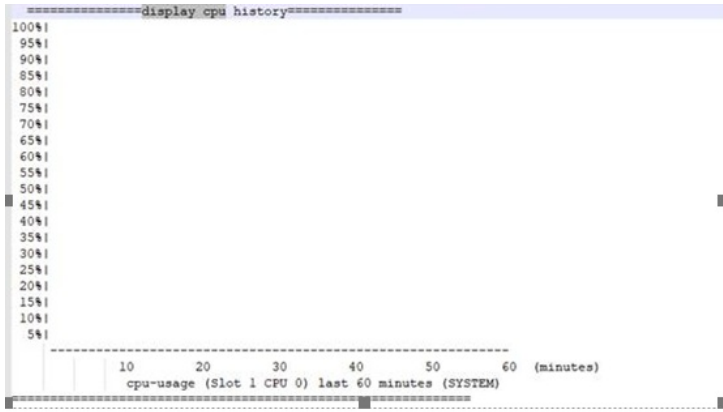
2、查看配置安全策略全放通且没有开启dpi，查看cpu和内存都是正常的没有异常信息：
