【MSA】MSA Gen6阵列系统存在LEFTOVR硬盘影响对等固件更新(PFU)示例

硬件相关 孙清雷 2024-10-16 发表

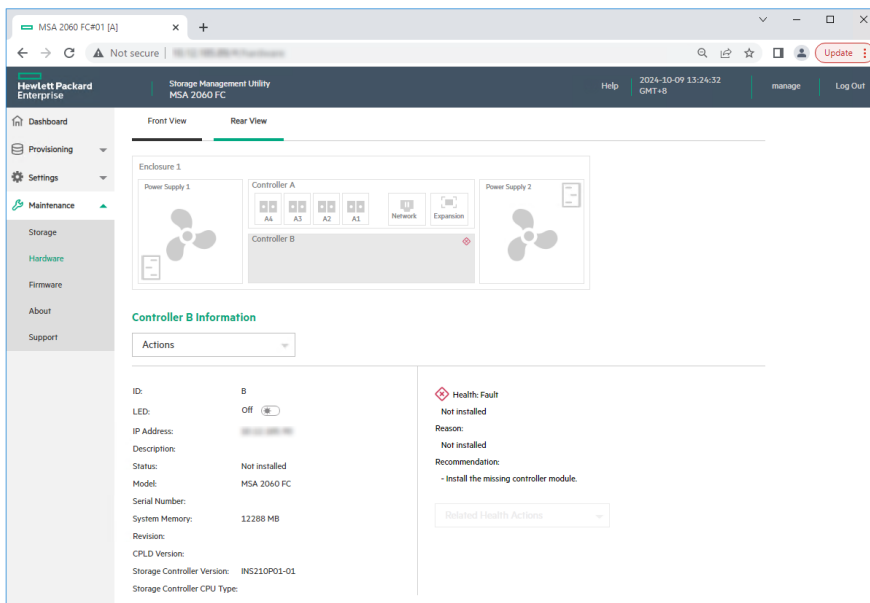
受测阵列为MSA2060 FC，固件版本为IN210P001。目前，B控呈故障状态。

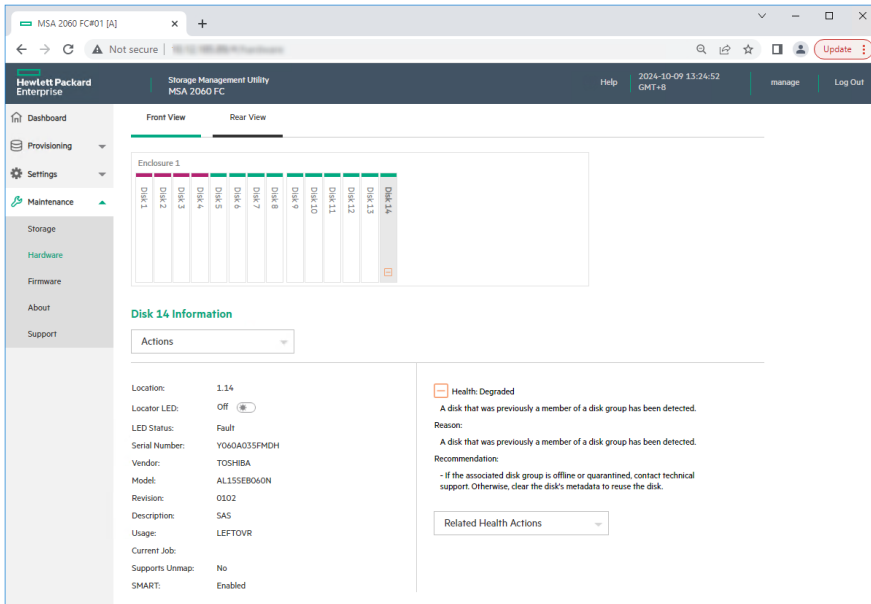
同时，阵列系统内14号硬盘为LEFTOVR硬盘，未及时更换或清除元数据。

手动将14号硬盘清除元数据，使其变为可用状态。

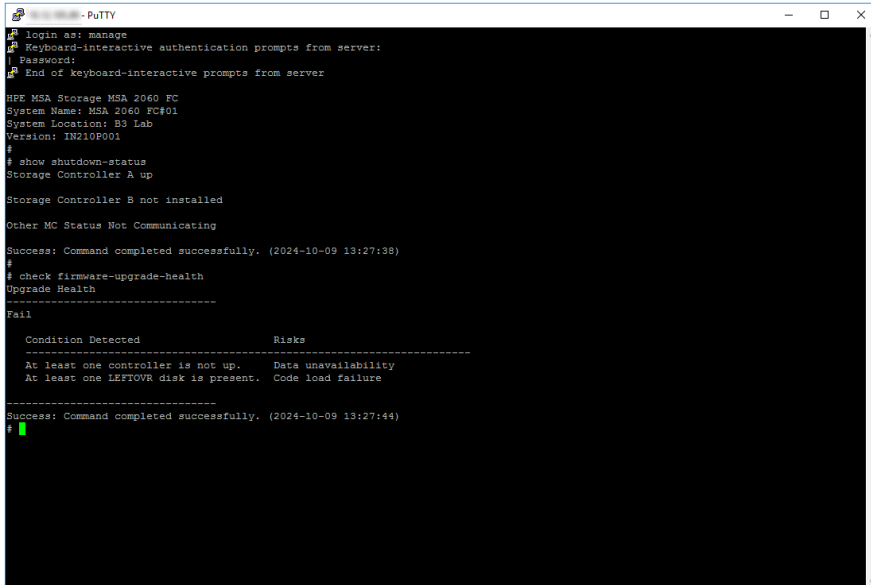
固件升级健康检查会提示有控制器未启动而存在数据不可用风险，此情况不会影响更换控制器后的对等固件同步。

同时，会提示存在LEFTOVR硬盘。

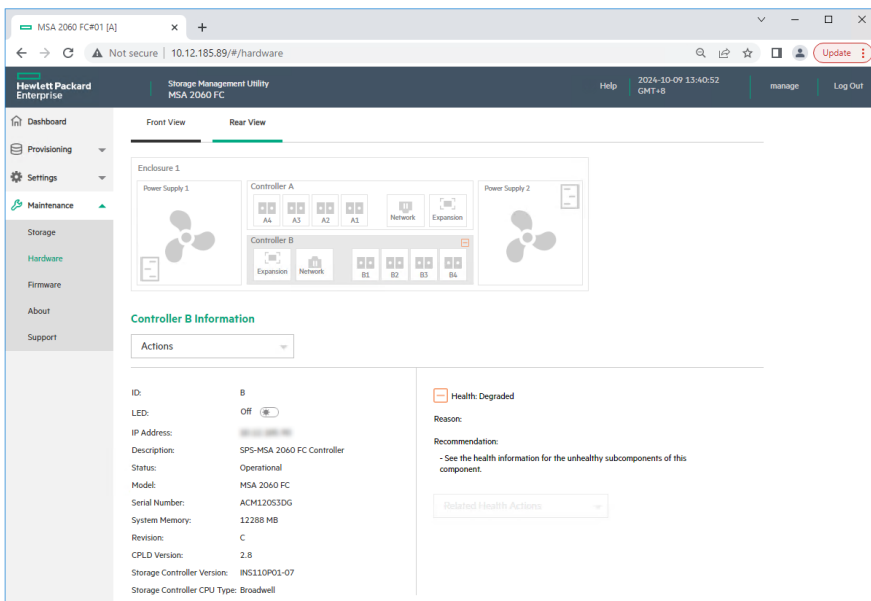
向B控槽位安装带有固件IN110P002的控制器备件，等待几分钟后，阵列系统已识别到新B控。

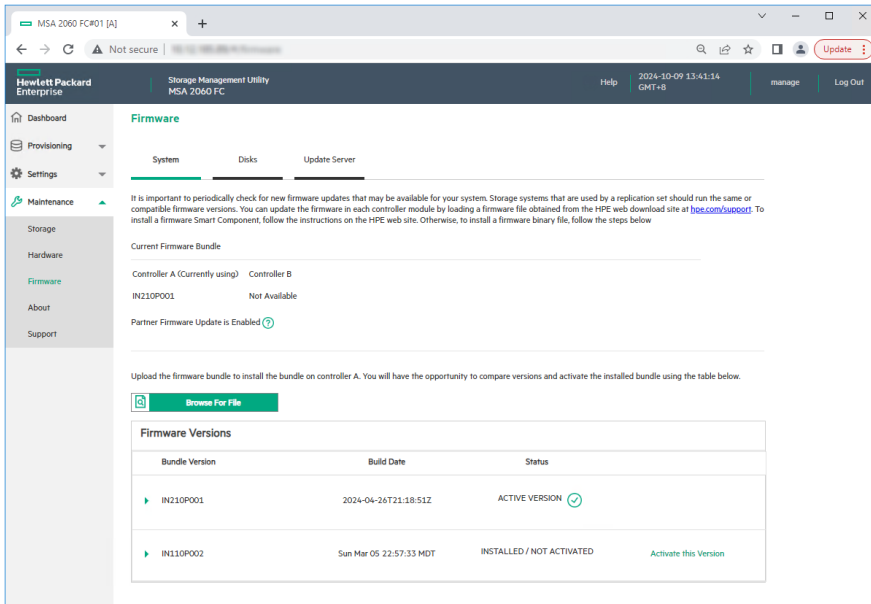
但固件视图中，新B控的固件信息为不可用。

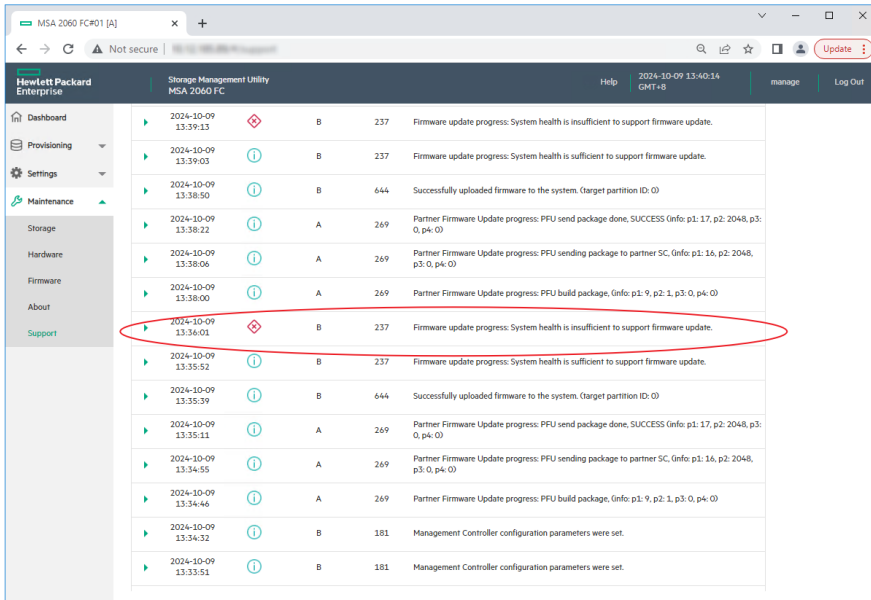
查看事件记录，可见新B控无法与A控进行对等固件更新，提示“Firmware update progress: System health is insufficient to support firmware update.”

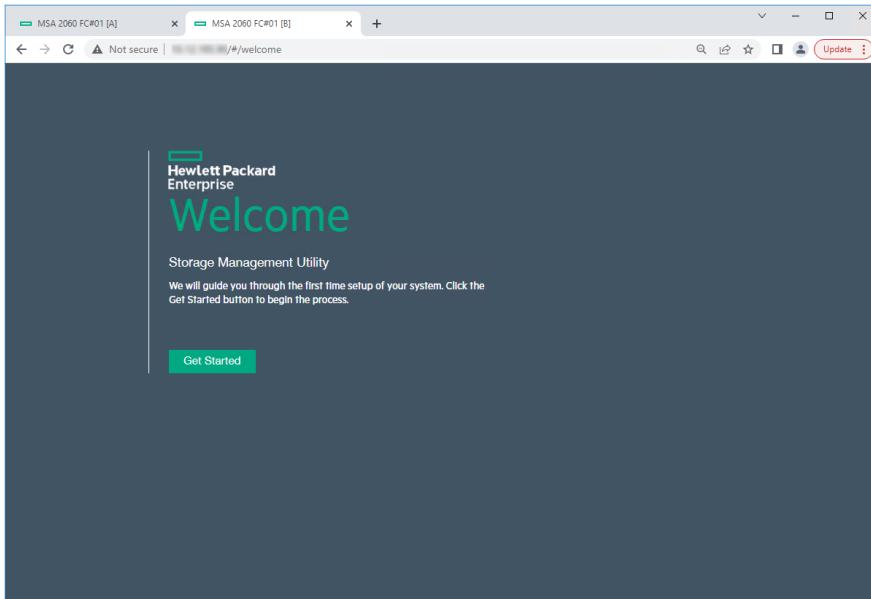
此时，通过B控的管理IP访问SMU，会提示系统需要进行首次配置。

如不修复影响固件更新的不健康组件，新B控会一直停止在这个阶段。

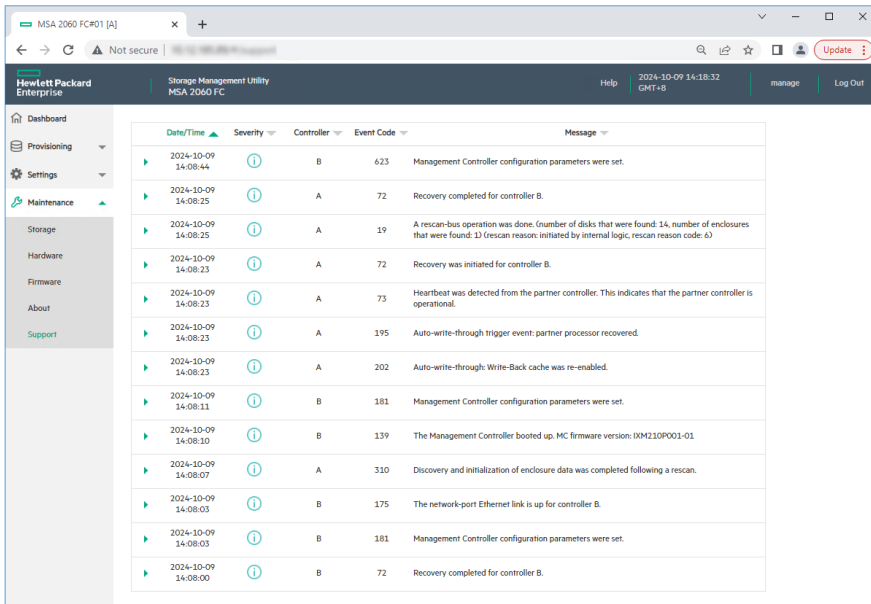
事件记录可见，在阵列系统内无LEFTOVR硬盘后，满足升级固件的健康要求，PFU正常进行。

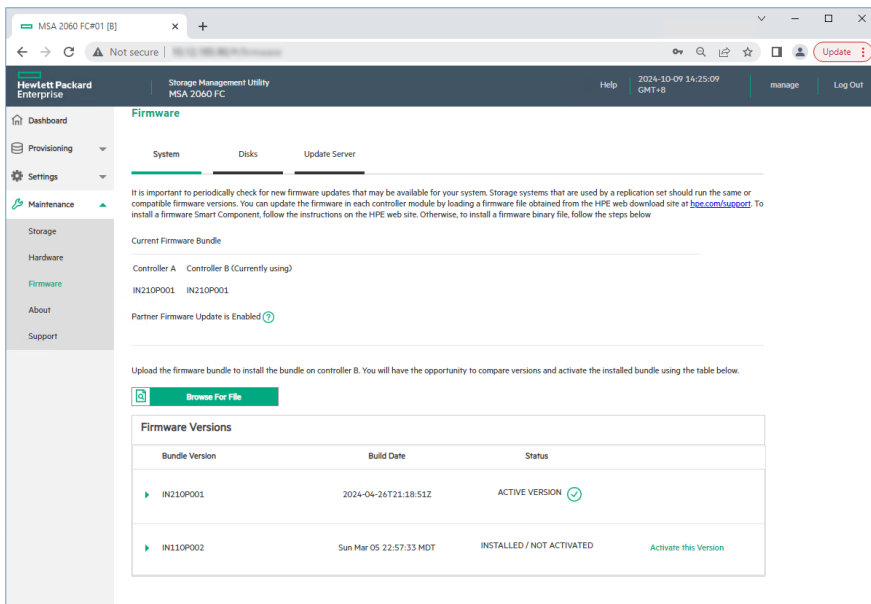
新B控完成对等固件更新后，其固件版本已升级至IN210P001。

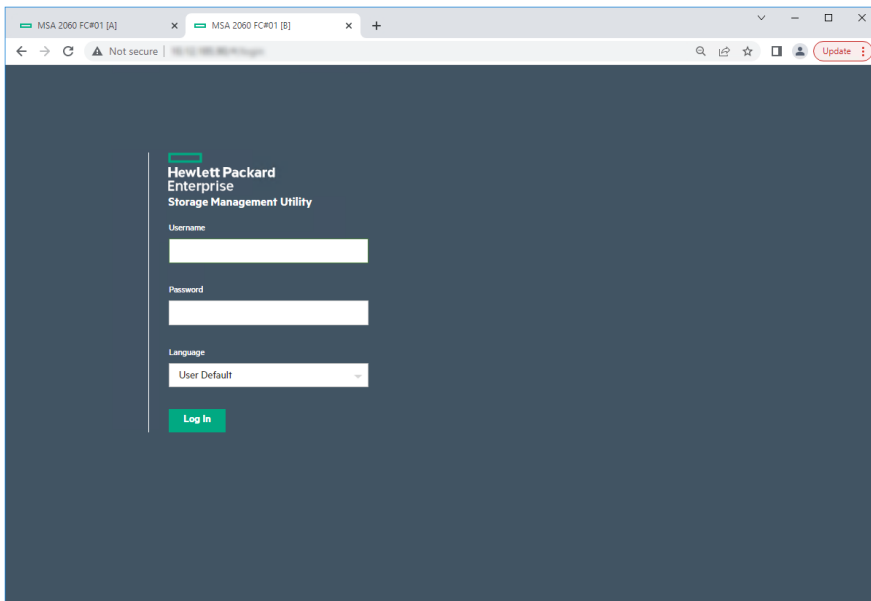
此时，通过B控的管理IP访问SMU，可正常登录，不再提示系统需要进行首次设置。
