## S5800交换机采用CCC模式部署VLL经验案例

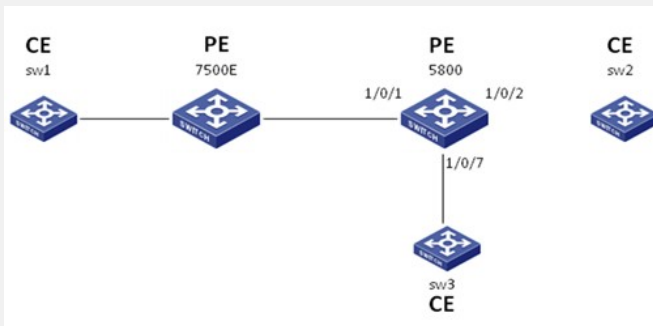
割接后拓扑：

1. 割接前SW1能够Ping通SW2，及14.1.1.44能Ping通14.1.1.4。
2. 将5800与SW2互联线拔出。
3. 由于5800中1/0/2口与1/0/7口配置一致，且SW2与SW3均存在VLAN14地址。如果SW1断开网络后，将SW3连接5800 1/0/7口，正常情况下，SW1能够Ping通SW3，及14.1.1.44能Ping通14.1.1.5
4. 通过步骤3测试，发现此时14.1.1.44不能Ping通14.1.1.5，故障产生。

CCC模式为VPWS，属于点到点二层服务。在5800交换机上CCC对绑定VLAN中最小端口进行绑定。测试网络中1/0/2和1/0/7均在绑定VLAN14中，因此设备仅绑定1/0/2口，不论1/0/2和1/0/7口是否UP/Down。

当SW2与S5800断开后，将5800的1/0/2口允许VLAN14通过的配置去掉，及undo port trunk permit vlan 14.执行后，由于此时1/0/2口已不属于VLAN14，因此绑定接口自动跟换为1/0/7口。再次测试发现14.1.1.44可以Ping通14.1.1.5。
