## 知 S5820V2 STP计算导致二层网络流量中断经验案例

STP 林洪宇 2018-03-19 发表

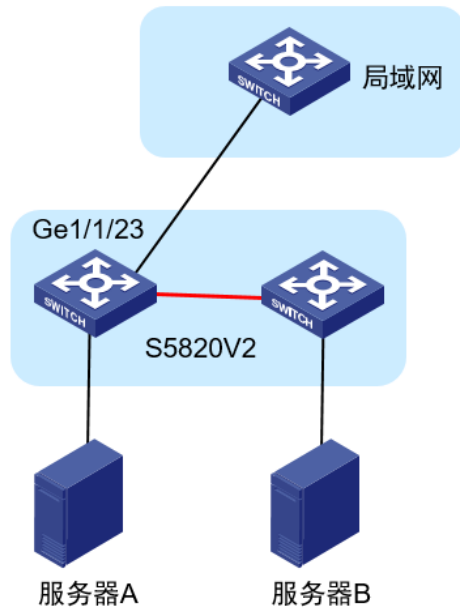
某局点组网拓扑如上所示：交换机S5820V2堆叠作为接入设备，下联第三方服务器，上联汇聚接入网络。

客户反馈现场故障当晚，由于上行其他设备发生故障产生大量TC报文，交换机S5820V2收到上联设备的发过来的大量TC报文，导致STP拓扑震荡，根桥不断发生变化，堆叠S5820V2上联端口的端口角色在指定端口和根端口之间变化，下联服务器业务流量出现中断十几秒的现象。

为了避免这种端口状态变化导致流量中断的情况发生, 端口状态实现快速迁移, 连接服务器的端口必须配置成为边缘端口。在现网设备开启STP的组网中, 一定要做好相关STP优化, 配置边缘端口, 配置根保护等, 防止由于一台设备的故障影响全网业务流量。

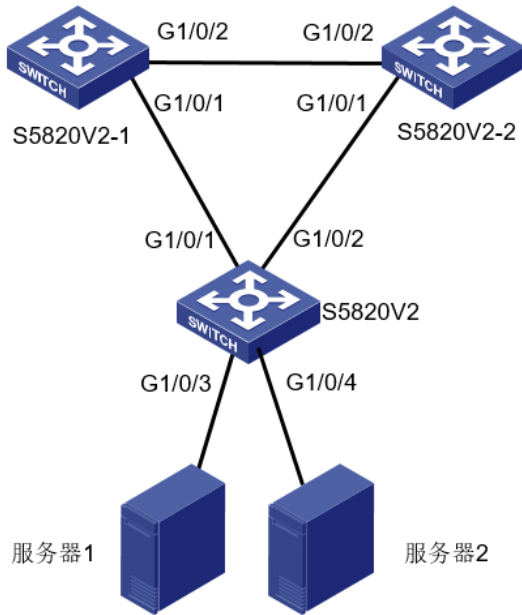
4、本地测试：三台S5820V2相连组成环形组网，使能MSTP生成树协议选择性地阻塞网络中的冗余链路来消除二层环路，通过配置调整路径开销和STP优先级使接入服务器的S5820V2上行端口G1/0/1和G1/0/2端口分别为根端口和指定端口，复现了服务器1和2之间PING包会存在中断的现象，但是奇怪的是，并不是每次G1/0/1和G1/0/2根端口和指定端口切换都会导致PING丢包的现象，进而整理测试过程，进一步分析：

如上图所示：S5820V2-1为生成树的根桥，S5820V2的G1/0/1和G1/0/2端口分别为根端口和指定端口，分别处于FORWARDING的转发状态。并且G1/0/3和G1/0/4端口下的服务器进行长PING测试，测试是否会产生业务流量中断的现象。
