## 某局点S7610x服务器切换到备网卡时组播流量不通问题

肖倩艳 2018-03-29 发表

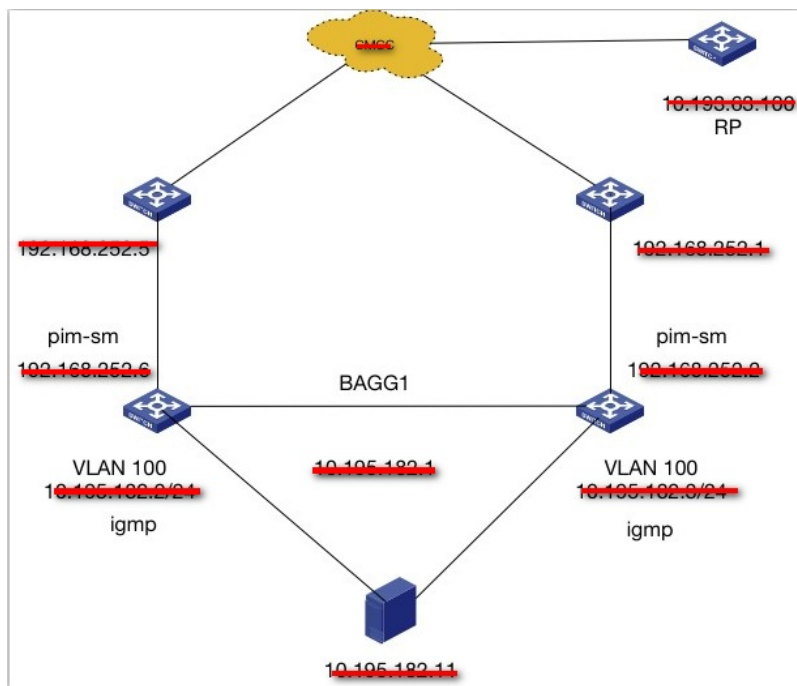
某局点客户反馈S7610x版本是R7556，服务器切换到备网卡时组播流量不通，现场组网如下

服务器地址是10.195.x.11两个网卡工作在主备模式，两台S7606做VRRP是服务器网关，网关地址是10.195.x.1,10.195.x.2是主设备。

分析现场组网知，只是服务器切换网卡时，vrrp主备并不会切换，服务器网关还是s7610x-1。流量走向应该是组播源-----7610x-1----链路聚合1---到7610x-2-----teng1/0/1---到服务器。

发现vlan100虚接口组播组管理协议IGMP是开启的，但是此时组播流量应该是二层转发的，让现场工程师尝试取消上述配置测试，测试结果是删除IGMP配置之后服务器备用网卡是可以收到组播流量的。现场7610x-2 vlan100开启IGMP是为了网关切换到此设备时用的，是不能删除的。最后和研发沟通，目前S7610x当前版本R7556是不支持上述组网的，建议更改组网。和现场沟通更改组网为IRF堆叠模式问题解决。
