# 知 VCM中无法识别到VC-FC

张红MA 2017-08-17 发表

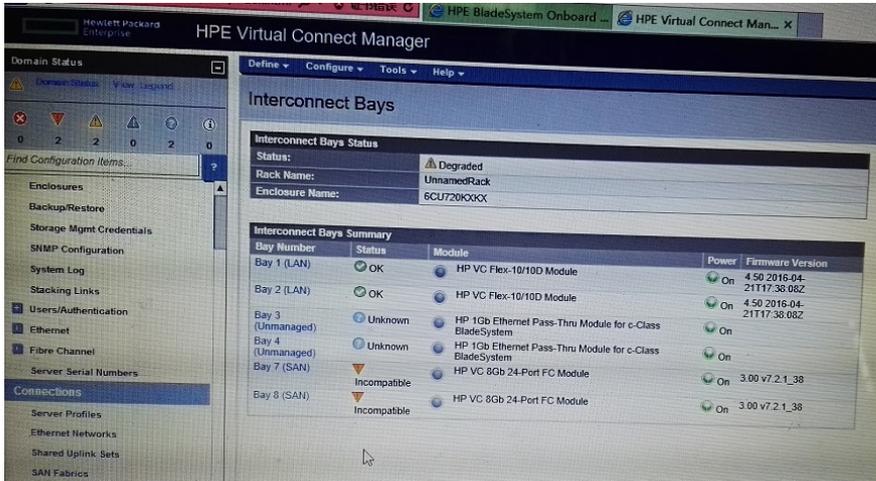
在VCM中有报错如下:

根据VCM inconnect BAY 中告警信息显示 当前BAY1 BAY2的10/10D VC固件版本为4.50. BAY5,BAY6 VC-FC固件版本为 3.00. 由于VCM管理刀箱中所有Vc模块, 需要固件版本匹配并兼容, 10/10D VC 4.50版本, VC FC的固件版本应该为3.05. Release note 如下:

使用VC最新固件4.60升级刀箱的VC模块。问题解决。升级后VCM报警消失, 如下图:

总结建议：VC固件版本的 Release notes中有详细说明 此版本对VC各个模块的支持 固件的对应关系。VCM管理该刀箱中所有VC模块，需要VC各模块固件版本的匹配。
