知 AC无线控制器的license特征不识别导致管理ap数量减少

License 姜霁琛 2018-11-12 发表

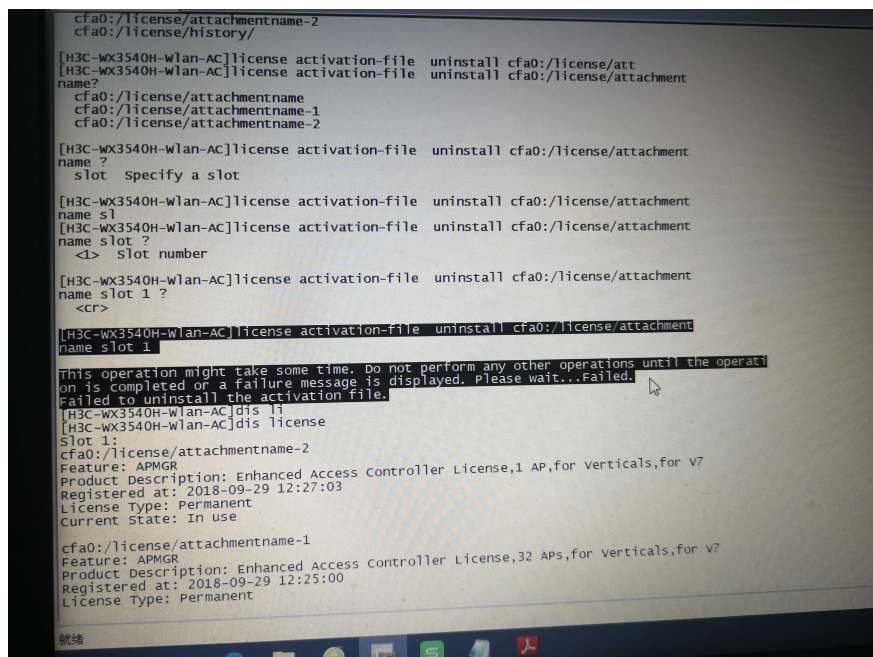
dis license看设备里的license状态，看到三个license都是in use状态，但是仔细查看发现第三个license的feature识别为“-”，另外两个都识别为APMGR。这种情况应该是这个license未被识别出来，所以现在设备可管理的ap数量变为了1+32=33个，正好是现在设备上看到的能够管理的ap数量。现场对设备进行了多次重启操作，故障依旧，且这个不能被识别出来的license无法卸载，卸载时提示报错：failed to uninstall the activation file.

判断出来具体是哪个license出问题后，使用more命令查看设备里未被识别出来的这个license的激活文件：attachmentname，对比另一个32ap的license的激活文件attachmentname-1，经过仔细对比后发现，两个文件内容一模一样！

怀疑是现场进行过什么误操作将ak文件内容做了改动导致此故障。建议现场将此激活文件从license路径下删除，然后重新将原始的激活文件导入设备license文件夹内，也把文件名改为attachmentname，然后重启设备。重启后设备恢复，license可正常识别。另外建议现场工程师，激活license时尽量不要对激活文件内容做改动，有可能造成激活失败的情况。
