知 MSR930-LM 3G拨号不成功经验案例

3G/4G拨号 高贵贤 2015-10-16 发表

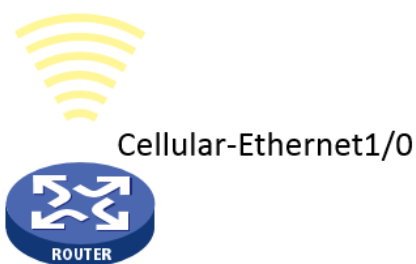
某高速公路收费站配置3G的VPDN应用，发现20多个站点都能正常拨号成功，只有一个站点拨号始终失败，客户反馈所有站点均使用我司的MSR930设备

电信3G网络

现场MSR930-LM的自带DM11-2 modem不支持电信3G, 可以支持电信4G, 建议现场更换为4G卡, 或者更坏支持电信3G的MSR930设备
