## IRF分裂后备设备部分端口未被Mad Shutdown经验案例

VLAN IRF2 MAD BFD 茆新楼 2019-05-28 发表

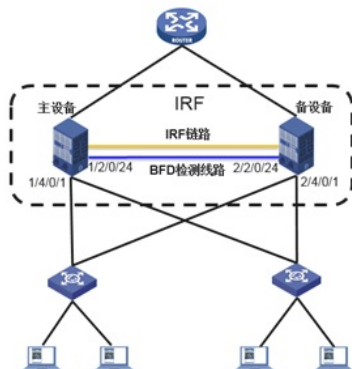
客户现场有两台S7506E做了IRF，采用BFD MAD方式来监测IRF的状态。在做IRF分裂测试时，IRF物理端口手工shutdown后，发现备设备连接接入交换机的物理接口未被mad shutdown，上连的三层物理端口以及vlan-interface都被mad shutdown。

当物理接口允许BFD MAD检测专用vlan通过后，接口会被当做BFD MAD检测接口。IRF分裂时，IRF物理端口、BFD MAD检测接口以及用户配置的保留聚合接口的成员接口自动作为系统保留接口，不会被关闭。

- 1、在连接接入交换机的物理口上undo port trunk permit vlan 3，IRF分裂后备设备的相关接口正常被mad shutdown。
- 2、用作BFD MAD检测的vlan是专用的，不要把正常的业务端口加入到这个vlan内。
