知 MSR2600-10 4G VPDN拨号不成功解决办法

3G/4G拨号 VPDN 高子军 2019-06-27 发表

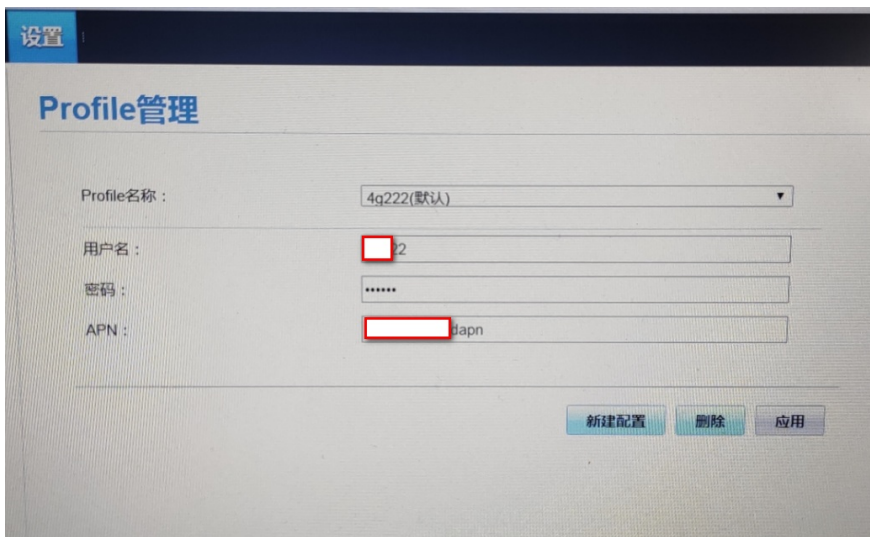
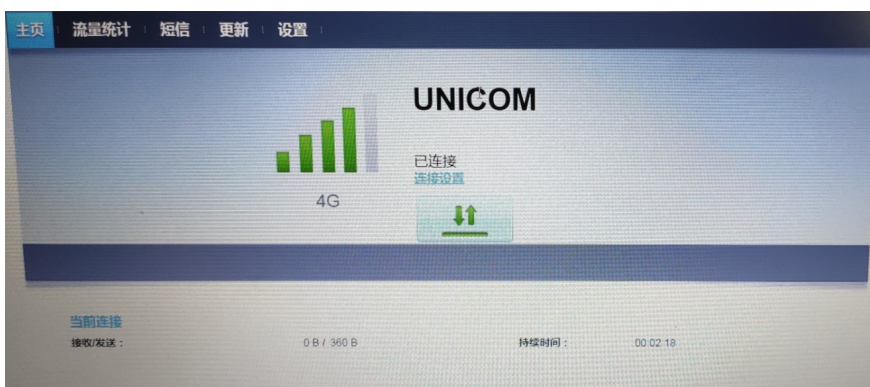
4.将该卡装到电脑上测试，配置相同的APN接入点测试，发现能正常拨入到VPDN网络，并且工作在4G网络。测试发现运营商的4G网络是正常的。

运营商在后台调整后该手机卡能正常通过4G拨入VPDN网络。
