1、组网拓扑如下

3、故障现场

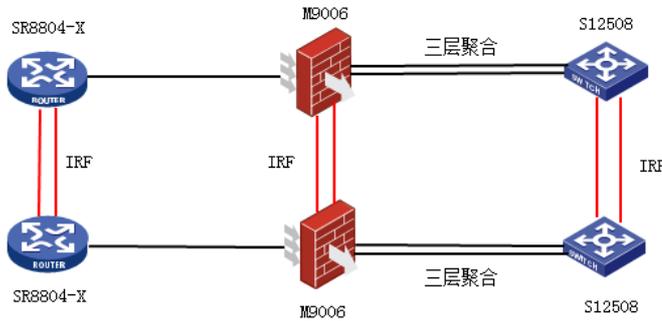
拔掉主框和S12508三层聚合链路的其中一条物理链路，设备冗余组成功从主框倒换到备框；然后将拔掉的物理链路插上，发现接口灯亮了大概30s之后就灭了，接口down的原因是冗余组shutdown，但是长时间观察发现设备一直没有倒回主框（默认倒回延迟1分钟）

- 1、设备正常情况下（即不做主备框切换时），业务流量转发正常
- 2、修改配置测试，将三层聚合接口下选中端口最小数量配置删除，然后冗余组中track同时追踪聚合接口和物理接口；测试主备框切换故障依旧，无法倒回
- 3、倒回延迟保留默认配置，设置为0时不进行倒回，默认为1分钟之后自动进行倒回操作
- 4、为了排除物理链路的影响，业务正常转发时，采用shutdown接口的方式进行测试，而不是拔插光纤；shutdown接口之后，正常主框倒换到备框，然后执行undo shutdown时有如下报错信息：DRVPLAT /4/DrvDebug: -MDC=1; Bind the interfaces to one or two IRF ports or cancel the bindings on all of the m.根据报错信息来看，irf物理接口和业务接口放在一个芯片组上了

查看现场配置，irf物理接口为1/5/0/32、1/5/0/31、2/5/0/32、2/5/0/31，下联聚合物理接口为1/5/0/30、1/5/0/29、2/5/0/30、2/5/0/29，现场接口单板型号为NSQ1TGS32SF0，IRF物理接口和业务接口在一个芯片组上，该接口单板4个接口为一组，每一组的接口跑得业务类型必须一致，包括S12508上接口选择也是一样的，更换业务聚合接口之后主备倒换倒回操作测试正常

- 1、接口单板上每一组接口的用途必须一致（大部分单板四个接口为一组，具体参考手册），即要么组内所有接口用作IRF，要么组内所有接口用作业务
- 2、聚合接口如果配置了最小或者最大选中端口（link-aggregation selected-port maximum/minimum x），本端和对端设备务必配置成一致
- 3、设备支持手动倒回和自动倒回，自动倒回默认开启延迟1分钟倒回，如果时间配置成0设备不执行倒回操作
