3、故障现场

拔掉主框和S12508三层聚合链路的其中一条物理链路，设备冗余组成功从主框倒换到备框；然后将拔掉的物理链路插上，发现接口灯亮了大概30s之后就灭了，接口down的原因是冗余组shutdown，但是长时间观察发现设备一直没有倒回主框（默认倒回延迟1分钟）

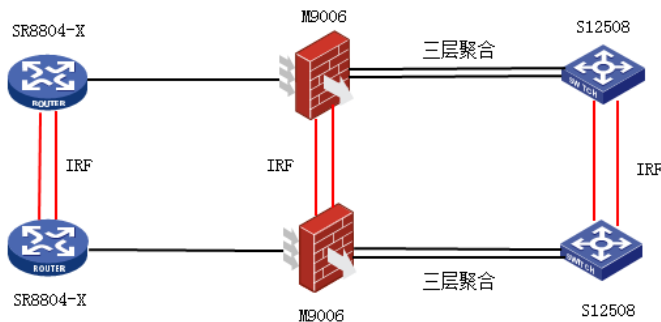
1、组网拓扑如下

- 1、设备正常情况下（即不做主备框切换时），业务流量转发正常
- 2、修改配置测试，将三层聚合接口下选中端口最小数量配置删除，然后冗余组中track同时追踪聚合接口和物理接口；测试主备框切换故障依旧，无法倒回
- 3、倒回延迟保留默认配置，设置为0时不进行倒回，默认为1分钟之后自动进行倒回操作
- 4、为了排除物理链路的影响，业务正常转发时，采用shutdown接口的方式进行测试，而不是拔插光纤；shutdown接口之后，正常主框倒换到备框，然后执行undo shutdown时有如下报错信息：DRVPLAT /4/DrvDebug: -MDC=1; Bind the interfaces to one or two IRF ports or cancel the bindings on all of the m.根据报错信息来看，irf物理接口和业务接口放在一个芯片组上了

查看现场配置，irf物理接口为1/5/0/32、1/5/0/31、2/5/0/32、2/5/0/31，下联聚合物理接口为1/5/0/30、1/5/0/29、2/5/0/30、2/5/0/29，现场接口单板型号为NSQ1TGS32SF0，IRF物理接口和业务接口在一个芯片组上，该接口单板4个接口为一组，每一组的接口跑得业务类型必须一致，包括S12508上接口选择也是一样的，更换业务聚合接口之后主备倒换倒回操作测试正常

- 1、接口单板上每一组接口的用途必须一致（大部分单板四个接口为一组，具体参考手册），即要么组内所有接口用作IRF，要么组内所有接口用作业务
- 2、聚合接口如果配置了最小或者最大选中端口（link-aggregation selected-port maximum/minimum x），本端和对端设备务必配置成一致
- 3、设备支持手动倒回和自动倒回，自动倒回默认开启延迟1分钟倒回，如果时间配置成0设备不执行倒回操作
