## 知 某局点SR6602-X2部署本地端口镜像后目的端口没流量

镜像 郝聚显 2019-07-08 发表

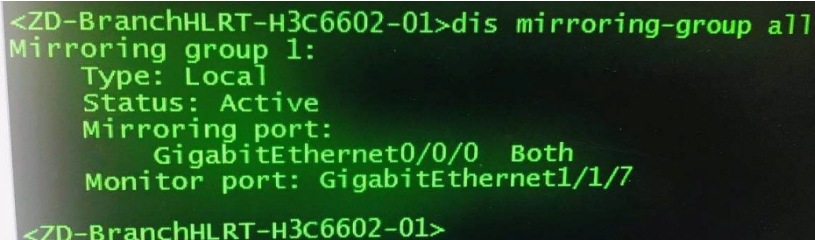
2、查看了镜像组的状态是active的状态

```
<ZD-BranchHLRT-H3C6602-01>dis mirroring-group all
Mirroring group 1:
  Type: Local
  Status: Active
  Mirroring port:
    GigabitEthernet0/0/0 Both
  Monitor port: GigabitEthernet1/1/7

经确认客户的业务在子接口上，镜像子接口的流量，源端口应该配置在子接口上，修改配置后解决。
