某局点S6300交换机stp震荡下挂存储中断案例

STP 二层链路聚合 于欣欣 2019-10-09 发表

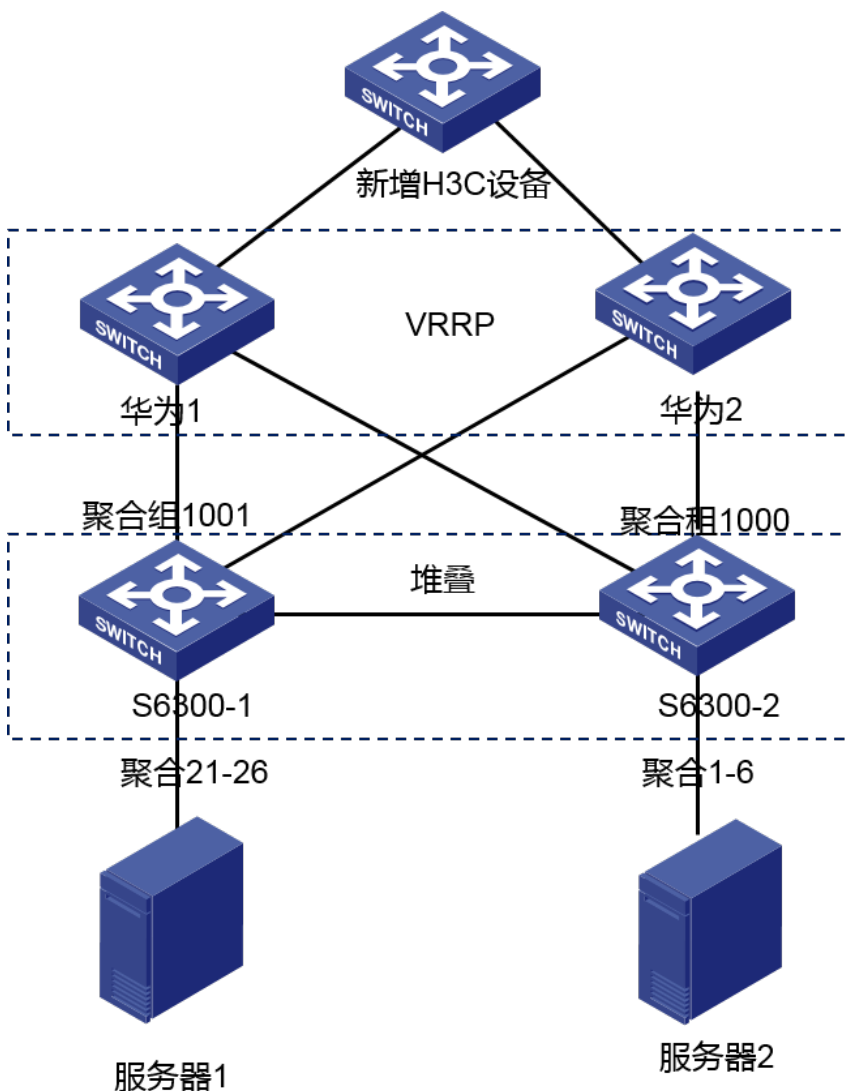
新加交换机===两台华为交换机 (vrrp) == (bagg1000, bagg1001) 6300===服务器、存储
