金融pos与前置机无法正常通讯案例

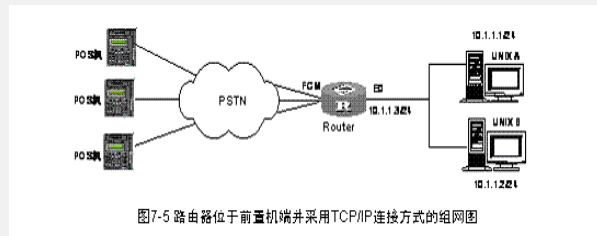
图7-5 路由位于前置机端并采用TCP/IP连接方式的组网图

由此可以看出前置机收到了路由发过来的报文，并且已向路由回复报文，但是路由器于某种原因没有处理并转发
