知 S5130-EI交换机下联话机自动识别voice-vlan自动获取IP地址失败问题案例

VLAN 语音 赵杰 2016-09-18 发表

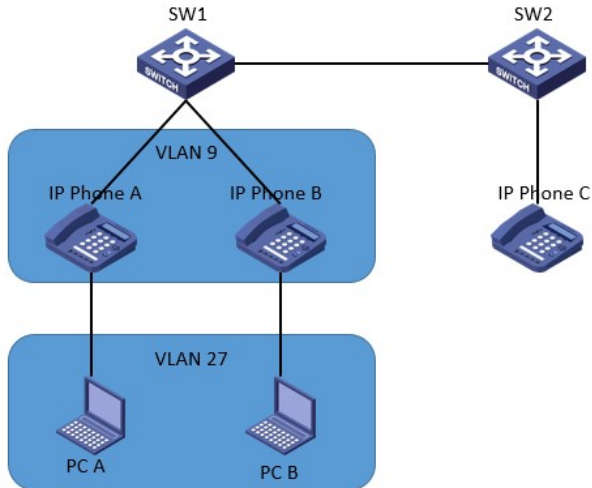
客户需求：客户使用我司S5130-EI作为接入交换机，HW的IP电话连接到交换机端口，IP电话下连业务PC，HW的IP电话属于vlan 9（voice-vlan），业务PC属于vlan 27。客户要求IP电话和业务PC通过DHCP方式自动获取地址，IP电话使用即插即用方式，通过LLDP协议协商voice-vlan。

问题现象：IP电话可以获取地址，下联业务PC无法获取IP地址。

更改交换机配置解决问题：
