## S10500交换机OSPF Router ID冲突问题排查案例

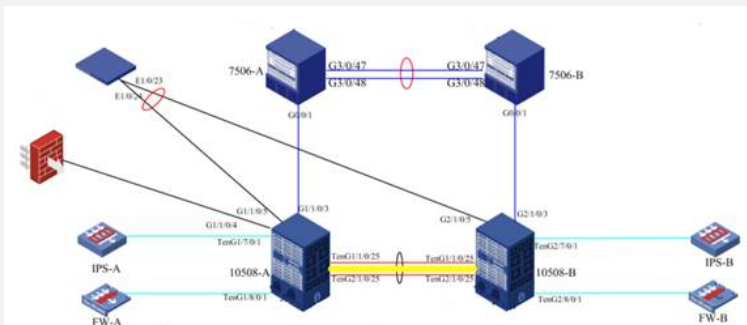
两台S10500做IRF，分别插一块IPS、FW插卡，作为核心设备采用OSPF与网络内其他设备交互路由协议。
