F1080 PING大包丢包问题排查思路及解决方法

会话 虚拟分片重组 **刘嘉炜** 2018-09-27 发表

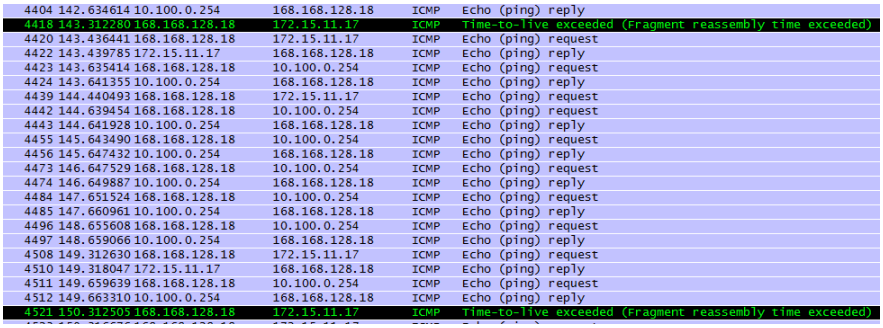
Line protocol state: UP
Description: Ten-GigabitEthernet1/0/25 Interface
Bandwidth: 10000000 kbps
Maximum transmission unit: 1500
Internet protocol processing: Disabled
交换机：
Vlan-interface51
Current state: UP
Line protocol state: UP
Description: to SHX_FW_H3C_F1080
Bandwidth: 10000000 kbps
Maximum transmission unit: 1500
Internet address: 172.15.11.18/30 (primary)
两端接口MTU等信息完全一致，所以此问题应该不是出在报文分片上。
二、抓包分析
在电脑丢包时进行抓包，发现很多丢包都是因为数据分片无法重组导致的丢包。Fragment reassembly time exceeded表示这个包的发送方之前收到了一些分片，但是由于某些原因迟迟无法组装起来。注：可能看到Time-to-live有些人会想到TTL超时，进而错误分析出路由环路的结论，一定要注意括号里面的内容。

4404	142.634614	10.100.0.254	168.168.128.18	ICMP	Echo (ping) reply
4418	143.312280	168.168.128.18	172.15.11.17	ICMP	Time-to-live exceeded (Fragment reassembly time exceeded)
4420	143.436441	168.168.128.18	172.15.11.17	ICMP	Echo (ping) request
4422	143.439785	172.15.11.17	168.168.128.18	ICMP	Echo (ping) reply
4423	143.635414	168.168.128.18	10.100.0.254	ICMP	Echo (ping) request
4424	143.641355	10.100.0.254	168.168.128.18	ICMP	Echo (ping) reply
4439	144.440493	168.168.128.18	172.15.11.17	ICMP	Echo (ping) request
4442	144.639454	168.168.128.18	10.100.0.254	ICMP	Echo (ping) request
4443	144.641928	10.100.0.254	168.168.128.18	ICMP	Echo (ping) reply
4455	145.643490	168.168.128.18	10.100.0.254	ICMP	Echo (ping) request
4456	145.647432	10.100.0.254	168.168.128.18	ICMP	Echo (ping) reply
4473	146.647529	168.168.128.18	10.100.0.254	ICMP	Echo (ping) request
4474	146.649887	10.100.0.254	168.168.128.18	ICMP	Echo (ping) reply

4484	147.651524	168.168.128.18	10.100.0.254	ICMP	Echo (ping) request
4485	147.660961	10.100.0.254	168.168.128.18	ICMP	Echo (ping) reply
4496	148.655608	168.168.128.18	10.100.0.254	ICMP	Echo (ping) request
4497	148.659066	10.100.0.254	168.168.128.18	ICMP	Echo (ping) reply
4508	149.312630	168.168.128.18	172.15.11.17	ICMP	Echo (ping) request
4510	149.318047	172.15.11.17	168.168.128.18	ICMP	Echo (ping) reply
4511	149.659639	168.168.128.18	10.100.0.254	ICMP	Echo (ping) request
4512	149.663310	10.100.0.254	168.168.128.18	ICMP	Echo (ping) reply
4521	150.312505	168.168.128.18	172.15.11.17	ICMP	Time-to-live exceeded (Fragment reassembly time exceeded)

这里想到V7防火墙是多核多线程的转发原理，也就是平时在设备上看到2-15都是属于转发核参与数据转发的。Comware V5\V7早期版本是逐包转发的，也就是数据包
备分片后可能通过不同VCPU处理，进而导致数据过防火墙后无法重组，所以将防火墙改为逐流模式就可以解决此问题。

防火墙的逐流模式也称为五元组模式，即匹配报文五元祖后上送同一个VCPU进行处理，从而规避数据分片后报文经过多个VCPU导致重组异常问题。
修改逐流模式的命令命令：
<H3C> system-view
[H3C] forwarding policy per-flow
