某局点S6800交换机EVPN组网堆叠切换丢包时间长

OSPF BFD IRF2 EVPN 苏亚东 2021-11-30 发表

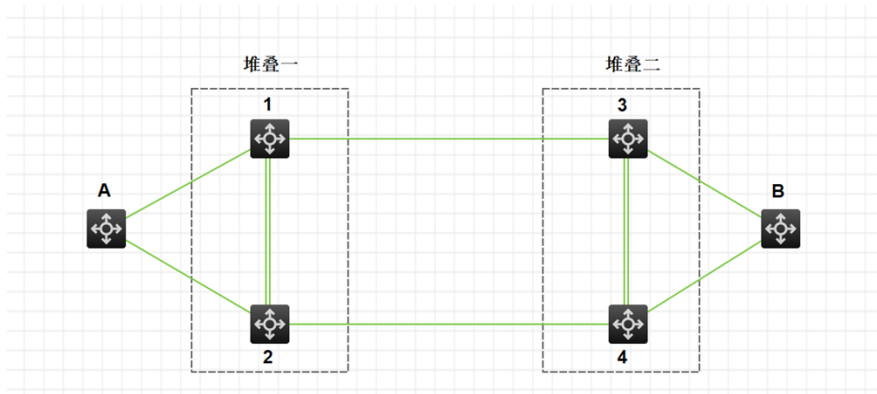
某局点两组堆叠中间通过各个设备的48口相连，跑的是运营商的波分线路，用于连接两个数据中心，堆叠设备的48口做了三层动态聚合。并且两组堆叠设备间建立了用于数据中心间互联的VXLAN隧道，该隧道由两组堆叠设备间建立的EVPN自动创建。两组设备间underlay采用OSPF，并建立BGP EVPN邻居，借此建立起tunnel 0用于传输数据中心间流量。OSPF进程上配置了BFD和GR，以保证堆叠切换时能够减少丢包数量。两组设备下联分别用二层聚合接口连接A、B两台数据中心汇聚设备，并且在二层聚合口上起AC，用于数据中心间流量的加解封装。A、B设备上起三层聚合口用于对接DCI设备，并切在A、B三层聚合口上起同网段的地址互联。

从反馈的信息来看，现场1-2堆叠，3-4堆叠，当设备3重启完成后重启设备4。从日志中查看，故障时设备1-2上在22:51:46时OSPF邻居恢复full，tunnel 0就up起来了；但是过了大约5S后（22:51:52）OSPF邻居又变成了exstart，因而导致underlay网络中断，tunnel 0 down。又过了2S（22:51:54）OSPF邻居恢复，同时伴随着BFD会话由down→up，而直至22:52:11 BGP邻居重新建立，tunnel 0重新up后网络通信可达。查看设备3上对应时间点的日志信息可以看到，OSPF邻居down的同时也有bfd会话down的信息。
