知 RBM+VRRP主备场景主设备上下行接口联动RBM状态切换DOWN

接口组联动 双机热备 曾招维 2024-12-21 发表

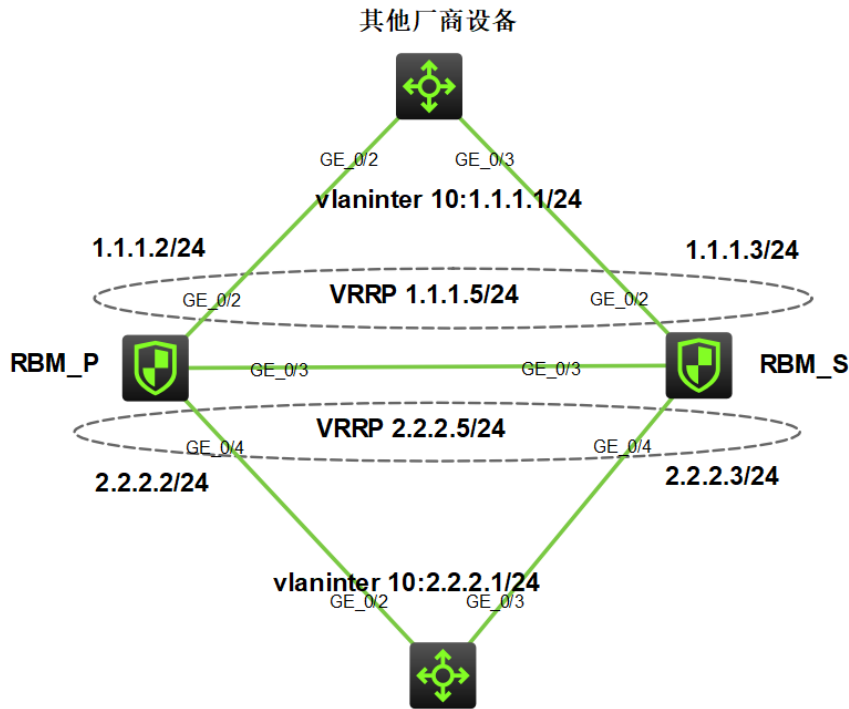
组网及说明

大致组网如下，两台防火墙做RBM+VRRP主备，上行接一台其他厂商设备，当RBM发生切换时，该厂商业务流量转发无法立即刷新，希望通过直接断开GE0/2接口的方式实现业务切换。RBM控制VRRP主备切换，不会联动接口物理、协议DOWN，现行主流版本也无法track启用vrrp的物理接口、进行监控联动DOWN，可以通过EAA方式实现需求。
