## 1 配置需求或说明

## 1.1 适用产品系列

## 1.2 配置需求及实现的效果

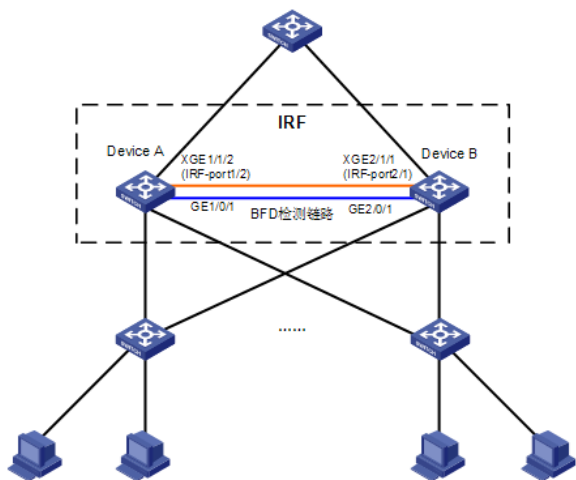
## 2 组网图

核心设备Device A和Device B配置IRF，为了防止万一IRF链路故障导致IRF分裂、网络中存在两个配置冲突的IRF，需要启用MAD检测功能，采用BFD MAD检测方式来监测IRF的状态，IRF分裂后，通过分裂检测机制IRF会检测到网络中存在其它处于Active状态，冲突处理会让Master成员编号最小的IRF继续正常工作，其它IRF会迁移到Recovery状态（表示IRF处于禁用状态），并关闭Recovery状态IRF中所有成员设备上除保留端口以外的其它所有物理端口

# 创建VLAN 3，并将Device A上的端口GigabitEthernet1/0/1和Device B上的端口GigabitEthernet2/0/1加入VLAN3中。
