## 组网及说明

核心设备Device A和Device B配置IRF，为了防止万一IRF链路故障导致IRF分裂、网络中存在两个配置冲突的IRF，需要启用MAD检测功能，采用BFD MAD检测方式来监测IRF的状态，IRF分裂后，通过分裂检测机制IRF会检测到网络中存在其它处于Active状态，冲突处理会让Master成员编号最小的IRF继续正常工作，其它IRF会迁移到Recovery状态（表示IRF处于禁用状态），并关闭Recovery状态IRF中所有成员设备上除保留端口以外的其它所有物理端口

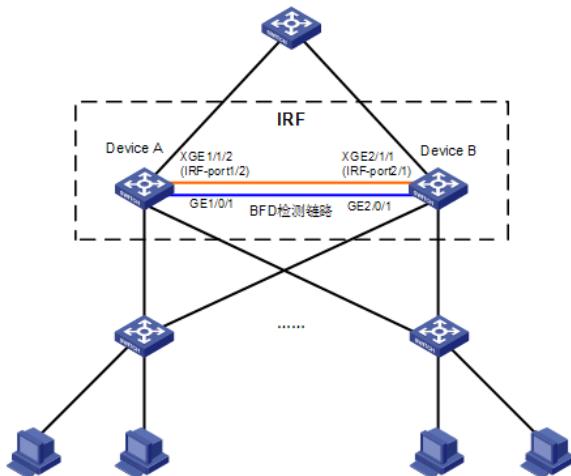
## 2 组网图

# 创建VLAN 3，并将Device A上的端口GigabitEthernet1/0/1和Device B上的端口GigabitEthernet2/0/1加入VLAN3中。
